R33 – 2022

Certificates of Appropriateness for work in the Historic Districts: 304 N. 15th Street, 1011 W. Linden Street, 1502 Chew Street, 106 N. 17th Street, 942 W. Liberty Street, and 405 N. 8th Street

**HISTORIC ARCHITECTURAL REVIEW BOARD
CITY OF ALLENTOWN, PENNSYLVANIA
February 7, 2022**

FINAL REVIEW

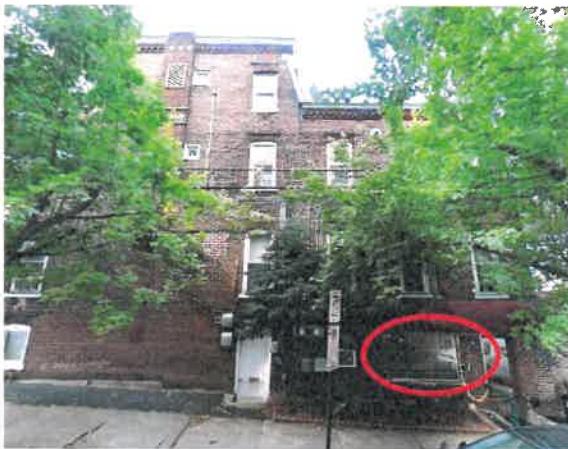
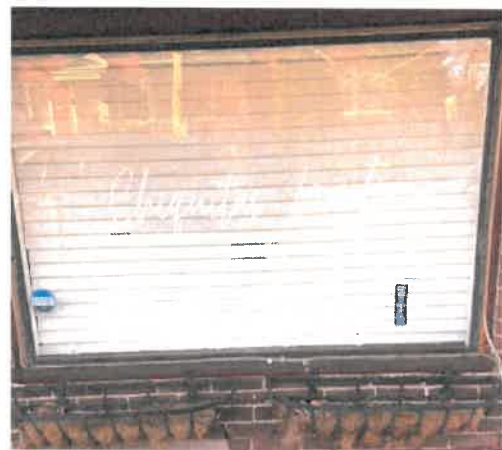
Item #4a- HDC-2021-00034
Address: 304 N. 15th St.
Proposed Alteration: Installation of new vinyl window sign
Historic District: West Park
Property Owner/Applicant: Yahaira Galarza

This 3-story end of row brick building with a corner tower, constructed, ca 1902 in a porch style at the corner of Chew and N 15th. There are multiple residential uses as well as basement level alk-in commercial use. The roof is flat with dentilated cornice and brick corbelling. The windows are 1/1 sash with brick lintels.

The proposed sign meets the Guidelines. It has a high degree of transparency and is a “long horizontally proportioned” sign for a commercial property. As an applied window sign, the proposed alteration is reversible and does not conceal architectural features or damage historic materials. The proposed sign is recommended for approval.

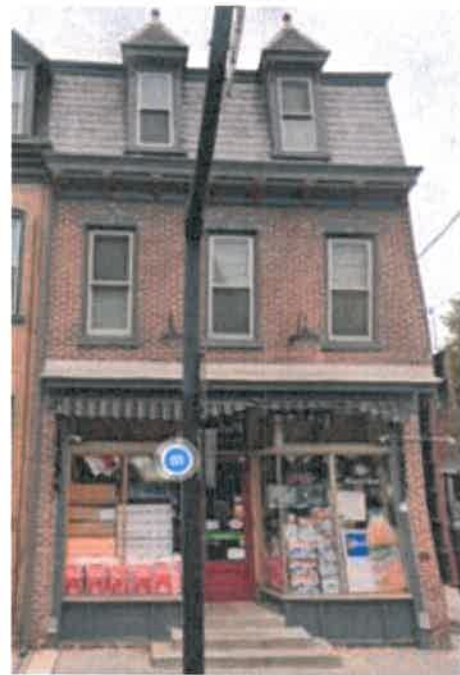
Item #4b- HDC-2022-00001
Address: 1101 W. Linden St.
Proposed Alteration: Installation of new window mullions on existing storefront
Historic District: Old Allentown
Property Owner/Applicant: Richard Thatcher

This structure is a 3-story attached brick dwelling with a mansard roof, dormers, projecting bracketed cornice, and first floor storefront. At the side façade, there are two entrances towards the rear of the property, one with a segmental brick arch and the other with a flat brick lintel. One of the doors appears to be original; it is wood with a half-light (now boarded over) over two panels. The building dates from c. 1887 and is Queen Anne in style.

The proposed work to repair the existing storefront meets the Guidelines. The proposed use of wood complies with the Guidelines and is consistent with the storefront's existing materials. Divided storefront windows are consistent with the storefront's existing appearance. Discussion of the proposed profile (flat or molded) for the mullions is recommended. A molded profile to match the frame at the upper transom windows is recommended. Proposed paint colors are not subject to review by the HARB.

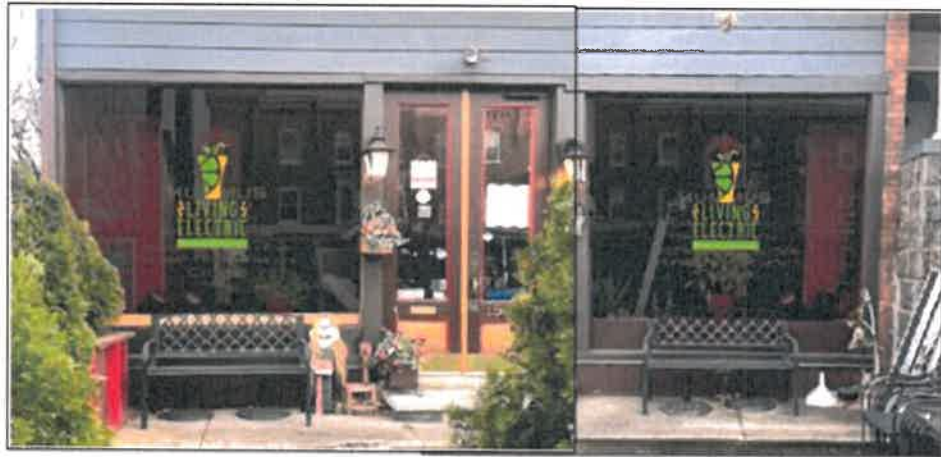
Item #4c- HDC-2022-00002
Address: 1502 Chew St..
Proposed Alteration: Installation of new vinyl window sign
Historic District: West Park
Property Owner/Applicant: Matthew Bevilacqua & Alyssa Buczynski

This 3-story brick end of row commercial and multiple dwelling units, ca 1902 is a Victorian style. The gambrel roof has projecting cornice and two dormers; one is a double dormer with gable roof and the 2nd

dormer has a barrel roof. The windows are 1/1 sash with bay window on 2nd floor and a single window to the right, the 1st floor has large commercial windows, a double 1/2-glass door on façade and three side doors, one is 1/2 glass, one is a wood panel, and one is a steel panel. The side of building has a steel fire escape, basement window grilles and a bay window, 1st floor porch and multiple adjoining garages with an Allentown shed roof. Most of the wood has been covered with aluminum on the house.

The proposed sign meets the Guidelines as an acceptable option. The overall size of the sign maintains the existing level of transparency at each window. Although not “long horizontally proportioned,” the sign appears proportional to the window size. As an applied window sign, the proposed alteration is reversible and does not conceal architectural features or damage historic materials. The proposed sign is recommended for approval.

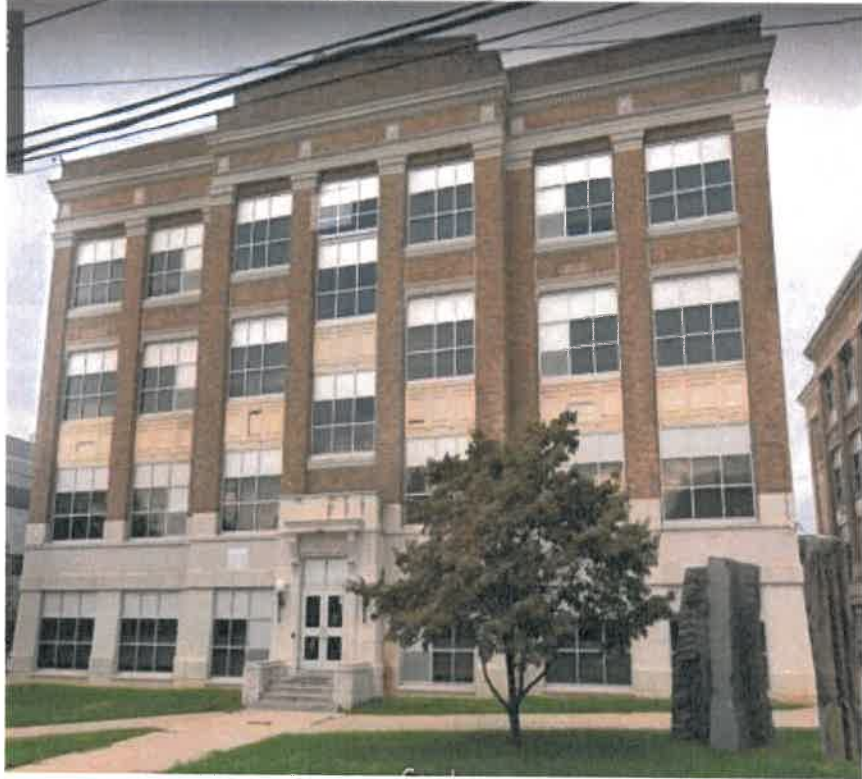
This four-story neoclassical high school was built circa 1916 of tan brick with limestone accents. The front entrance has two blue steel doors, with a light above and wall lights to each side. There is a four-step stone stoop leading to the doors.

The typical metal spandrel consists of an assembly of flat steel plates, angles and cast-iron moldings and trim. The panel contains 15 individual plates and molding pieces with applied decorative cast iron trim. The decorative trim pieces are fastened to the steel plate or cast iron with flat-head bolts which are visible on the exterior surface. The metal panels and cast-iron pieces have all deteriorated, are loose, falling and past their useful life. The proposed work includes removal of the deteriorated applied cast iron trim and install new fypon panels fabricated to matching existing details.

The proposed Fypon product is a polyurethane material. Polyurethane is not generally a recommended alternative material due to its short lifespan. The Guidelines state that repair and retention of existing historic features is encouraged and appropriate. The preferred preservation treatment would be to clean, repair and repaint the intact panel components and to replicate the deteriorated cast iron or steel pieces and replace them in-kind. Refer also to the Secretary of the Interior's Standards, and NPS Preservation Brief #27 The Maintenance and Repair of Architectural Cast Iron. Replacement with new steel to match the existing appearance would also be appropriate to maintain the continuity of materials.

Use of metal is recommended over polyurethane for replacement materials.

HARB member AJ Jordan made a motion to approve w/conditions the application dated 01/10/2022 for the replacement of the 18 existing metal panels below the windows at 106 N 17th Street with the following conditions agreed to by the applicant: replace the detail and profile to

match the existing in an alternative metal material formed into a panel to become part of a watertight assembly with a life expectancy of not less than 20 years, following the structural diagrams and drawings submitted in the application; and finds the application to be in compliance with the following sections of the Historic District Design Guidelines: Section 4 Wall, Siding and Trim and find that there are circumstances unique to the property: In that this is a unique structure with similarly designed buildings adjacent.

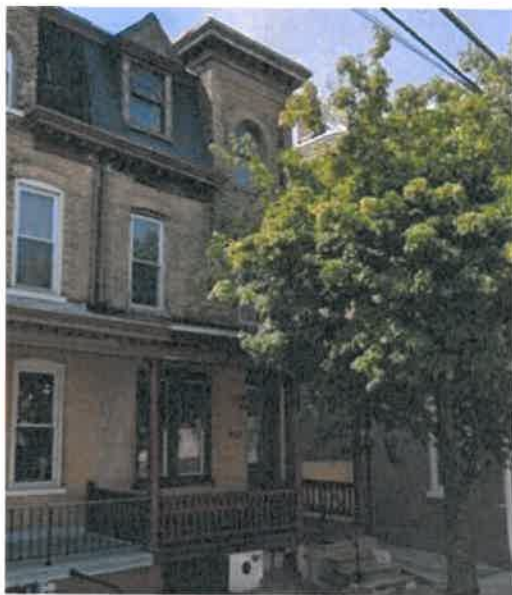
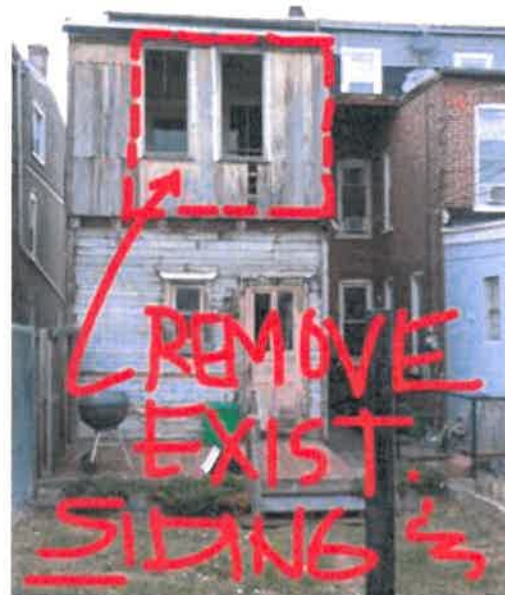
This 3-story brick end of row house ca 1900 is a Queen Anne porch house. The mansard roof is slate, and there is a tower at the west corner, with an arched window at the 3rd floor. The tower currently has a flat roof, and the single dormer has a gable roof with carving above the window. There is a pedimented dormer on the east half of the 3rd floor facade. The windows have arched brick lintels. The 1st floor windows are paired, the front door is ¾-glazed door with a transom. The front porch is wood with round columns, railings and visible basement windows. The basement entry is covered with a lid and surrounded by pipe railings.

The proposed work at the front porch meets the Guidelines with in-kind replacement of deteriorated wood features to match existing features and limiting replacement to missing or deteriorated components. The application notes that replacement of the porch roof may be required and EPDM black rubber roofing is proposed; if more deterioration is uncovered during repair work and roof replacement becomes necessary, the Applicant should contact Staff about the proposed work and materials. Note that EPDM roofing is generally not recommended (Guidelines, page 15).

At the rear porch, the proposed removal of non-historic siding is appropriate. The use of vinyl railings does not meet the Guidelines. If the two existing wood posts are deteriorated beyond repair, in-kind replacement with new wood turned posts to match the existing is the preferred preservation treatment.

HARB member Glenn Lichtenwalner made a motion to approve with conditions the application dated 01/18/2022 for replacement of deteriorated porch elements including beams and ceilings as well as replacement of existing vertical siding, window frames and deteriorated posts from an enclosed rear porch with vinyl railings and similarly profiled vinyl posts; the front façade scope of

work includes replacement trim, brackets, moldings and related sections for roofing in kind to match the existing profile and dimension. The conditions presented and agreed to by the applicant include removing the scope of work related to the rear porch from this application to be resubmitted as a separate application when complete and approve the scope of work presented for the front façade and porch as submitted.

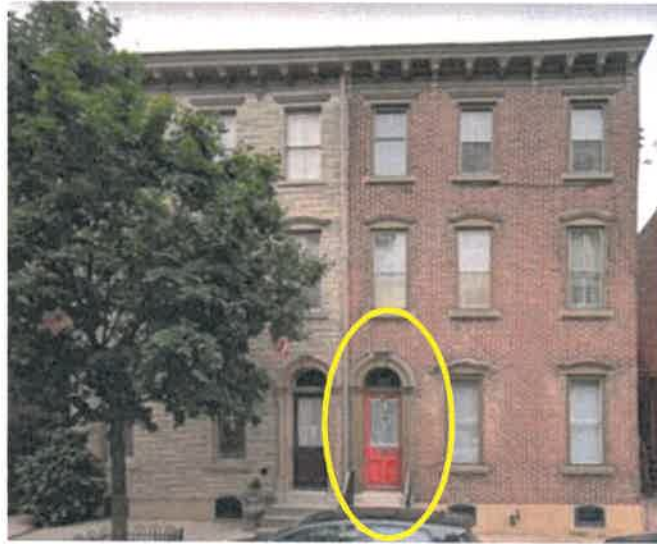
Item #5a- HDC-2021-00024
Address: 405 N 8th Street
Proposed Alteration: Replacement of Front Entry Door
Historic District: Old Allentown
Property Owner/Applicant: Madeline Velez Phillips & Benjamin Phillips

This 3-story brick twin house, ca 1877, has Italianate styling. The roof is gable with projecting eaves and a single chimney. The 2nd and 3rd floors have 2/2 sash windows, and the 1st floor has 1/1 sash windows with Italianate lintels. There is a single glazed door with a half-round transom and projecting moldings. The front has a stoop with an aluminum awning over it. The exterior walls are Allentown brick. There are two basement window grilles visible. There is a small addition between 403 and 405 N 8th Street, it has 2/2 windows on both floors with a 2nd floor door leading on to the fire escape, the stairs go up to a 3rd floor level with a railing across to the steps.

Owner provided a letter from Courtney Wood Products stating the door cannot be salvaged due to decay, the frame can be reused.

The Applicant has provided professional assessments as requested for repair of the existing door, which state that door cannot be repaired. The existing wood frame was determined to be useable for a new door and should be retained. The Guidelines indicate that the new door should match the historic in design, dimension, and glazing configuration. Fabrication of a new door to match the existing door would meet the Guidelines. However, the use of salvaged materials is a sustainable practice and generally appropriate as a preservation practice. As such the HARB may wish to consider the proposed use of a salvaged door as a unique circumstance.

HARB member Glenn Lichtenwalner made a motion to approve the application dated *10/01/21* for the replacement of the front door with a salvaged door at *405 N 8th St* as submitted and finds compliance with the following sections of the Historic District Design Guidelines: Section 6 Doors and find that there are circumstances unique to the property: in that the existing door is non-repairable due to deterioration and the proposed salvaged door is acceptable.
