**Historical Architectural Review Board  
COA Preliminary Review Sheet**

**HDC-2025-000112**

**Address: 202 N 8th Street**

**Proposal: Replace door with historical appropriate wooden door**

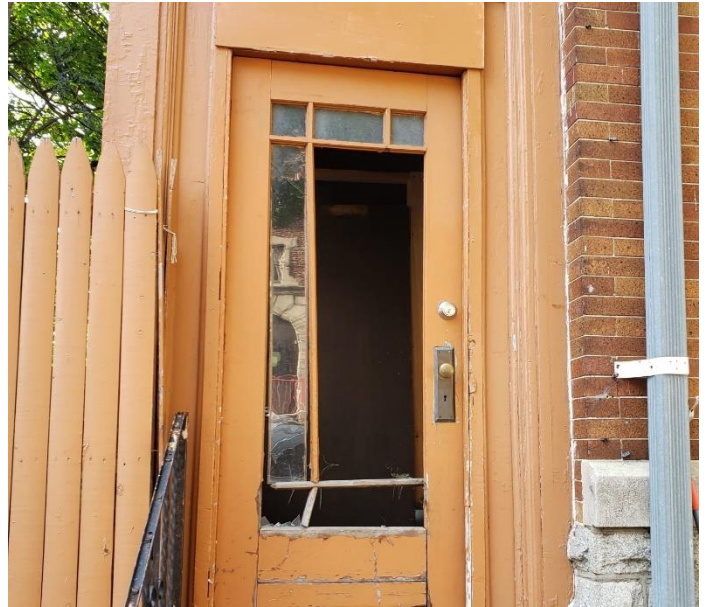
**ORIGINAL DOOR**

The HARB discussed the proposed door, and potential appropriate configurations. Google Maps imagery from 2016 indicate that the previous door was not the original; a 6-pane door was in place at that time. The previous door, and the 2016 door were both complementary styles to the building.

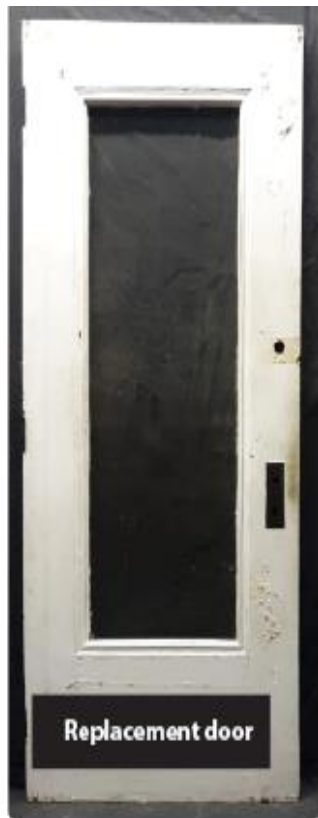
32"x78.5"x1.75" Antique Vintage Old Rec  
Salvaged SOLID Wood Wooden Exterior  
Door Window Beveled Glass

### PROPOSED DOOR

The applicant is seeking to replace a side/rear entry door. The previous door was damaged, and a tenant replaced the door with a non-appropriate style door. The applicant presented a salvaged single lite wood door. Door hardware was not included in the application materials; Mr. Hart noted that door hardware contributes to the historic visual aesthetic of the building.

- The replacement door is of historic material, meeting historic dimensions, sized to the original dimensions
- That the lite dimension is 4, 6, 9, or 15 lites
- The hardware is in keeping with historic guidelines
- All modifications approved by staff prior to installation
