**Historical Architectural Review Board  
COA Preliminary Review Sheet**

**HDC-2025-00035**

**Address: 931 Gordon Street**

**Proposal: Replace slate steeple roof**

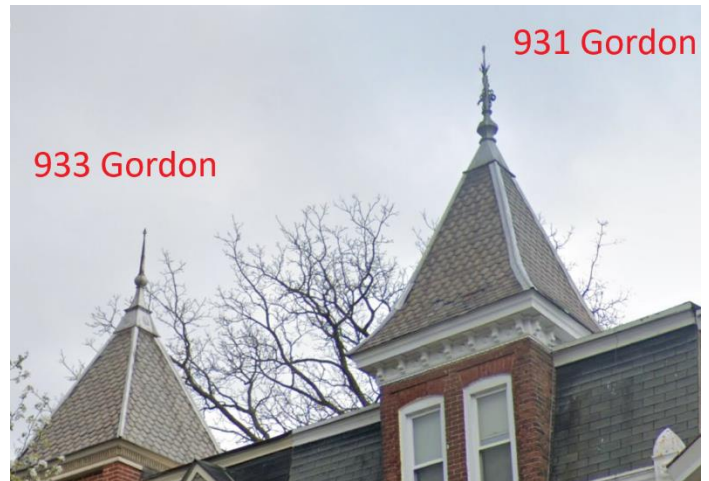
Steeple Roof at Subject Property and Neighbor (Applicant)

**5/5/25 Observations & Comments:** The slate steeple is a defining feature of the façade at 931 W. Gordon Street. Beveled and rectangular shingles create a dynamic pattern on the steeple.

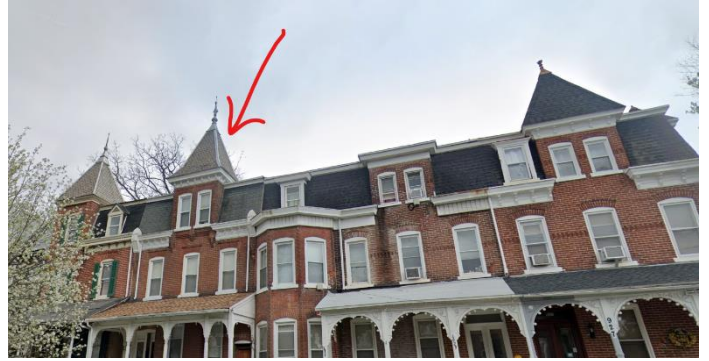
**Projected Work Area- Steeple (Applicant)**

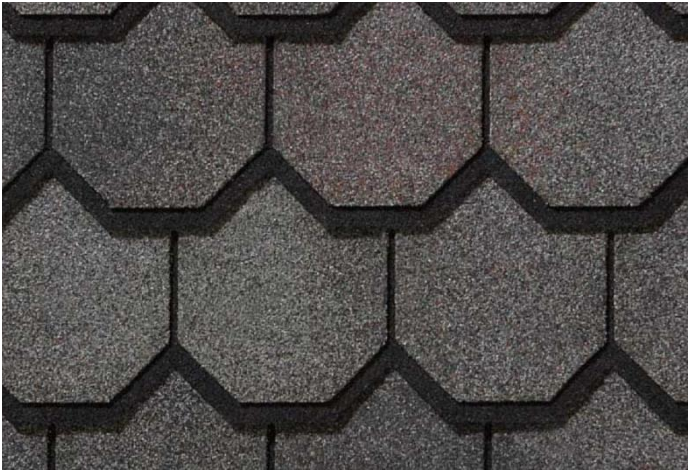
**Proposed Shingle – CertainTeed Carriage House Shingle  
(Applicant)**

While the proposed replacement product is of a similar beveled shape, replacement in-kind or with a synthetic slate would be appropriate. The size of the shingle also appears to be larger than the size of the slate shingle. More information would be helpful to understand if repairing the existing roof has been explored. If repair is not feasible, an appropriate alternative would be an alternative slate-look roof, such as GAF Slateline, or similar. Replacement materials should match the existing in color, pattern, shape, size, and profile.

- The proposed GAF Slateline and the proposed Certaineed Carriage House shingles are used in a unique pattern to replicate the existing pattern of the slate roof using four courses of Certaineed Carriage house shingles to one course of Slateline.

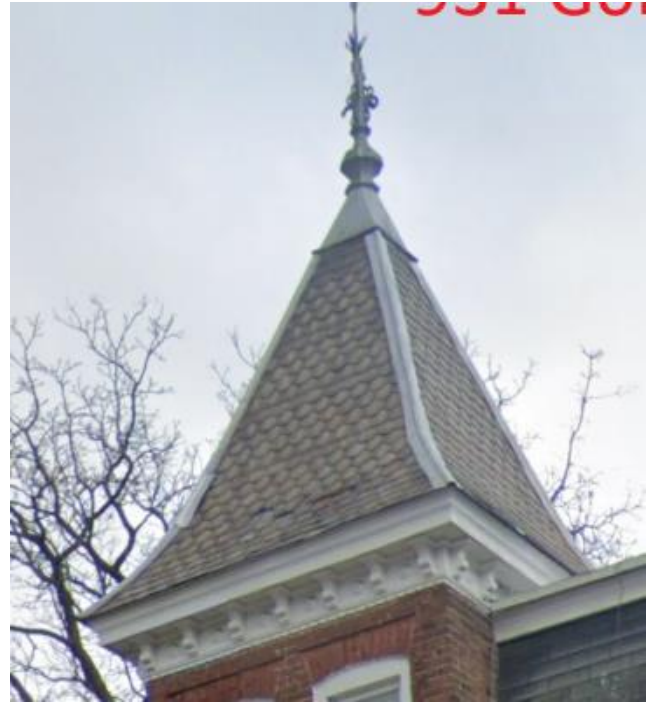
**Current Steeple (Applicant)**

The applicant brought a sample of the existing slate which fell off the steeple roof. He noted that he tried to reinstall slate shingles, which broke in the reinstallation process. While reviewing the existing steeple more closely, the slate towards the bottom of the steeple were observed to be in poor condition. The applicant brought samples for potential alternate materials, including the material proposed at the May 2025 HARB meeting, and GAF Slateline shingles. Mr. Jordan noted that the Slateline shingles were not consistent with the shaped slate- the current configuration of the slate installation is a combination of rows of rectangular/straight slates and rows of beveled/scalloped shingles.

If the current slate is beyond repair, the applicant proposes to use two styles of asphalt shingles to create a similar pattern as the current slate; however, the colors for the different shaped shingles are similar but not a complete match. Mr. Encelewski noted that maintaining the patterning of the shingles would be great and acknowledges that the slate appears to be in disrepair. Mr. Hart expressed concern about the loss of slate materials throughout the districts is a major issue but would defer to the board about the best alternate material. Ms. Shreier has concern about mixing two product types to replicate the pattern. Mr. Huber expressed that maintaining the pattern would be important to maintaining the character of the steeple and that it should be reflected in any replacement. Mr. Hammond preferred the shaped asphalt alternate material. Mr. Jordan said that there is evidence that the roof is in worse shape than anticipated and noted that the patterning of the existing roof is important across the board. The applicant noted that mixing two product types is physically possible and is open to a variety of options as recommended by the board.
