HISTORIC ARCHITECTURAL REVIEW BOARD CITY OF ALLENTOWN, PENNSYLVANIA February 1, 2021

FINAL REVIEW

Case # HDC-2021-00006

Address: 301 N 8th Street

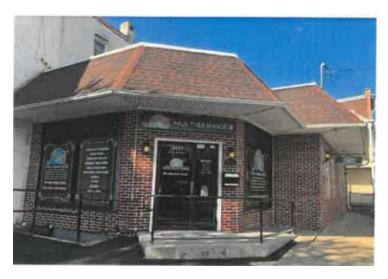
Building description, period, style defining features: The building was constructed ca. 1927 as an auto service garage and is now used as an office. It is located on a corner lot and is set back from N. 8th Street by a parking lot. The one-story building has a chamfered corner entrance and an awning roof with a wide soffit. The primary facades are clad in brick veneer. The roof is clad with fiberglass shingles. There are four 1/1 double hung windows on the south facade and two large plate glass windows at the entrance. The entrance is a plate glass single door with fixed sidelight, accessed from a raised concrete landing and ramp with metal railing. The building's current appearance is the result of alterations in 2010 and 2011.

Evaluation of Proposed Project: The proposed replacement signage appears appropriate with minor modifications and will not negatively impact the building. The building was substantially altered in 2010-11 and little to no historic fabric remains. The proposed changes will not impact original material or character-defining features. New signage is proposed to be the same dimensions or similar scale to existing and should not have an increased visual impact on the building. In reviewing this application and the location, it was deemed a serif typeface would be more appropriate and the color palette for the typeface should be white or black, remove any special characters including the dollar signs and the accent details including borders and shading should consist of dark green, black and white.

Recommendation(s): The proposed replacement signage with recommended modifications including using a serif typeface in white or black for lettering with the exception of the logo and the proposed color palette for accent details including borders and shading should consist of dark green, black and white. The proposed changes will satisfy the correction of the violation, is appropriate and is recommended for approval.
