# Historical Architectural Review Board COA Preliminary Review Sheet

**HDC-2025-00053**

**Address:** 427 N. Lumber Street

**Proposal:** Replace front first floor window.

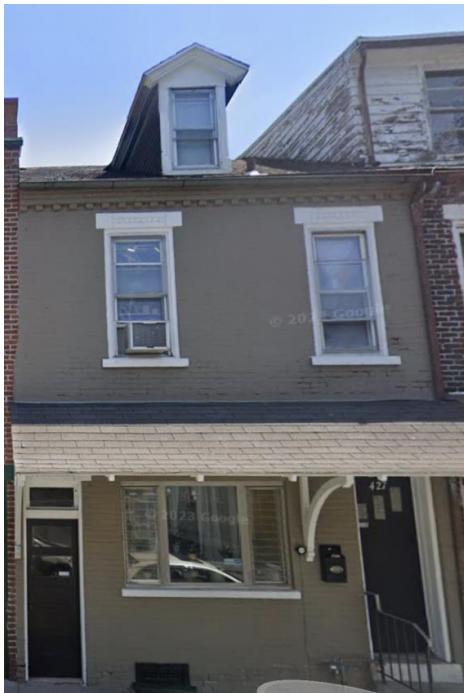
**Building Description:** The building is a two and one-half story red painted brick row house and is a composite street vernacular or Federal Victorian with Eastlake lintels. It has a gable roof with asphalt shingles and dentilated cornice. There is a single dormer, and the chimney is shared. The windows are two over two sash on the second floor and the dormer. The first floor has a large window with jalousied sides. There is a basement window grille. The main entry is single with three small squares of glass and a transom. The grocer's alley has a plain transom. The concrete stoop has a marble threshold. There is a wrought iron railing, and an Allentown bell roof. There is a garage in the rera. The modern front door and first floor window are not in keeping with the style.

**Current Front Elevation (Applicant)**

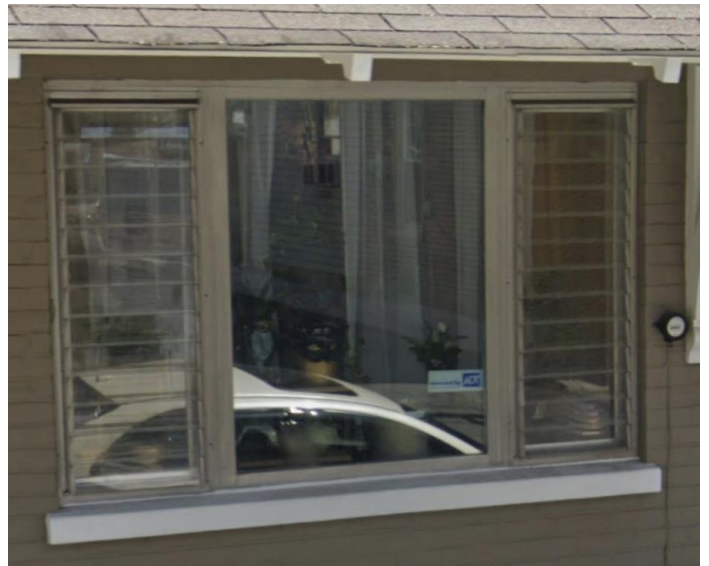
**Current Window Proposed to be Replaced (Applicant)**

**8/4/2025 Observations & Comments:** The current existing first floor window is a metal framed window with two jalousie sashes. It is not an appropriate window per the Guidelines in materiality and operation. The applicant is proposing a fixed vinyl picture window, similar to other picture windows on the block. The applicant states that that all other windows on the house had been previously replaced with vinyl windows, and this is the only one that is not vinyl and is also not original.

**8/4/2025 Staff Recommendation:** Pending window product information review to be submitted by applicant, staff recommend approval.

- That it is a fixed aluminum picture window that is to be factory-finished and may be black, and needs to not decrease the sightline of the existing window
- That the final window is subject to staff approval.

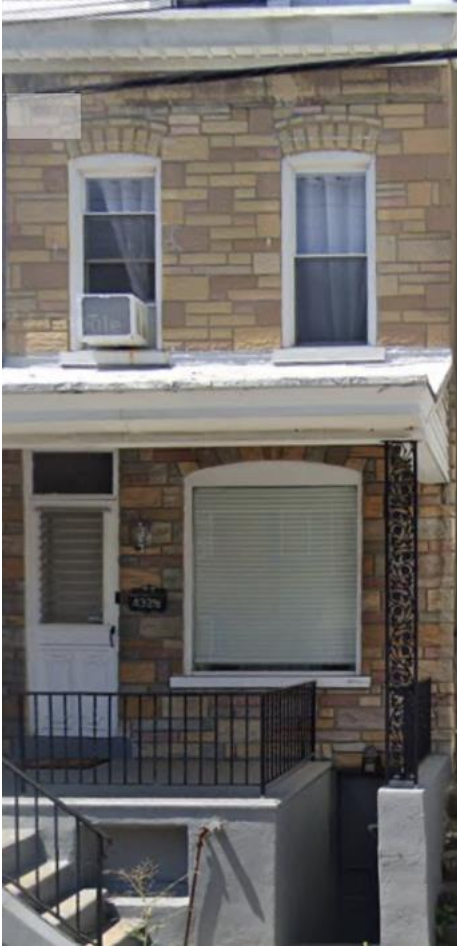
**Nearby Property similar to what Applicant is proposing(Applicant)**

While vinyl windows are not appropriate per the Guidelines, there is a unique circumstance in that all other windows on the front elevation were previously replaced with vinyl windows, and the proposed window configuration is in better keeping with other picture windows in the area than the current window
