**Historical Architectural Review Board**  
**COA Preliminary Review Sheet**

**HDC-2024-00117**

**Address: 927 Turner Street**

**Proposal: Legalization of 12 installed vinyl windows and tempered glass in front door.**

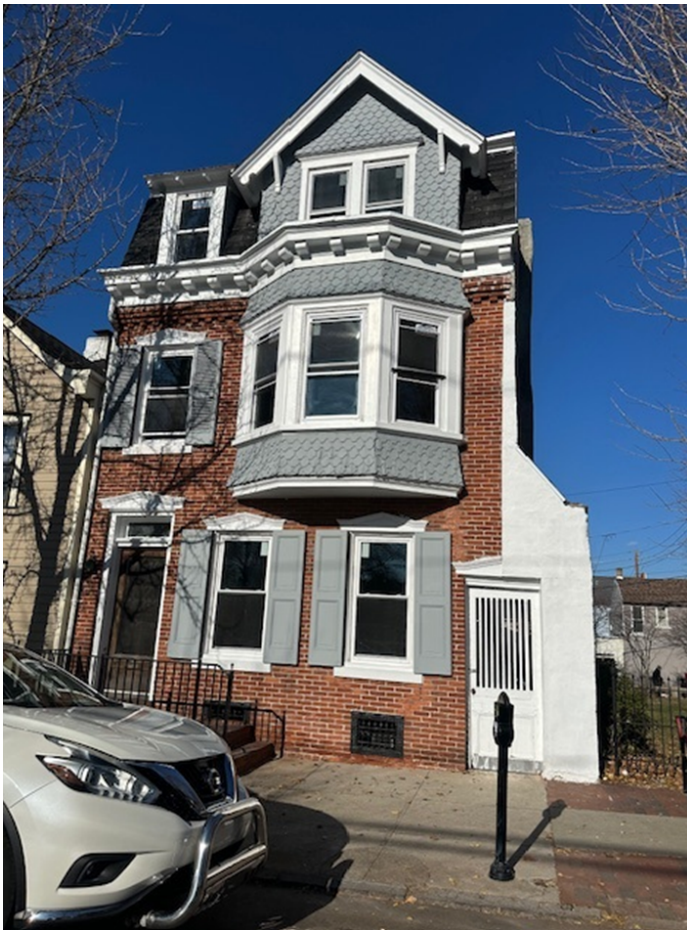
**Current Front Elevation (Applicant)**

**Building Description:** This 3-story brick row house, ca 1866 is Italianate style. The mansard roof has roll roofing, dentilated cornice, single chimney and a large double dormer with a smaller window on the left side. The windows are 1/1 sash with a bay window on the 2<sup>nd</sup> floor and a single window to the left. The windows that are single have Italianate lintels. The main entry is a single door with transom and Italianate lintel, there is a shared glazed grocer's alley door and two visible basement window grilles. There is a concrete stoop with railings and an iron fence in the rear.

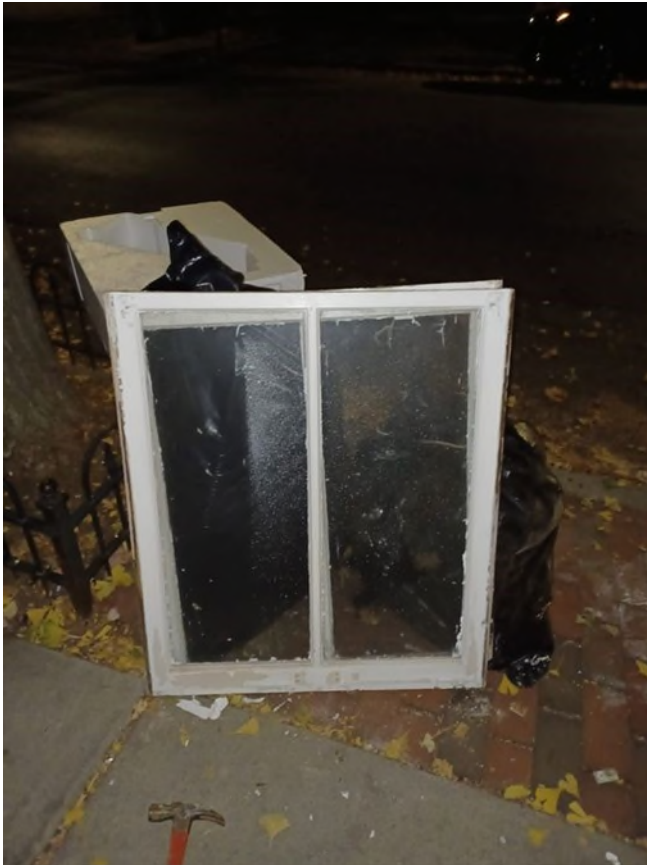
**Original Windows (Applicant)**

**Observations & Comments:** The installed vinyl windows are not appropriate per the Guidelines. It would be helpful if the owner/applicant can provide detailed photos of the windows prior to replacement, or evidence that they needed to be replaced rather than repaired. It appears that the configuration of the rear windows was not replicated in the replacement windows; they were previously two-over-two and are now one-over-one. A more appropriate replacement window would be wood windows, aluminum-clad wood, composite wood, or fiberglass.

**Staff Recommendation:** It is recommended to deny the application.

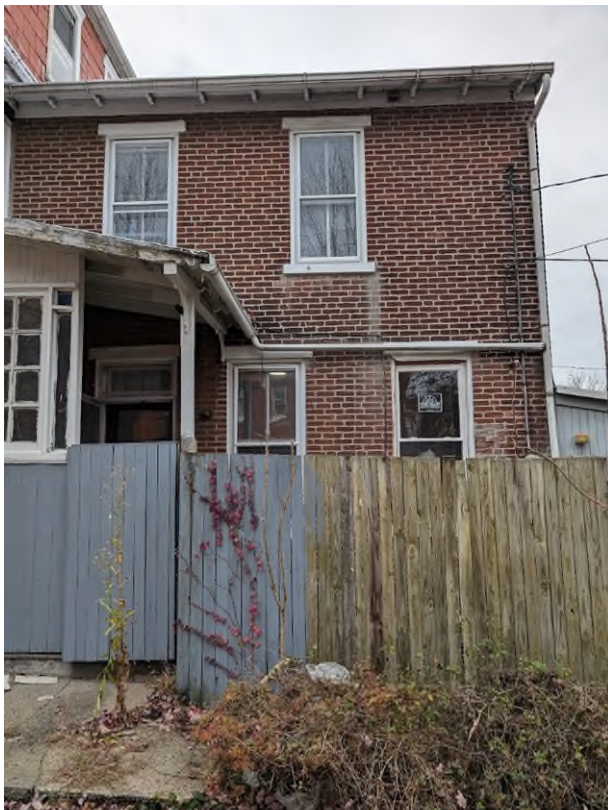
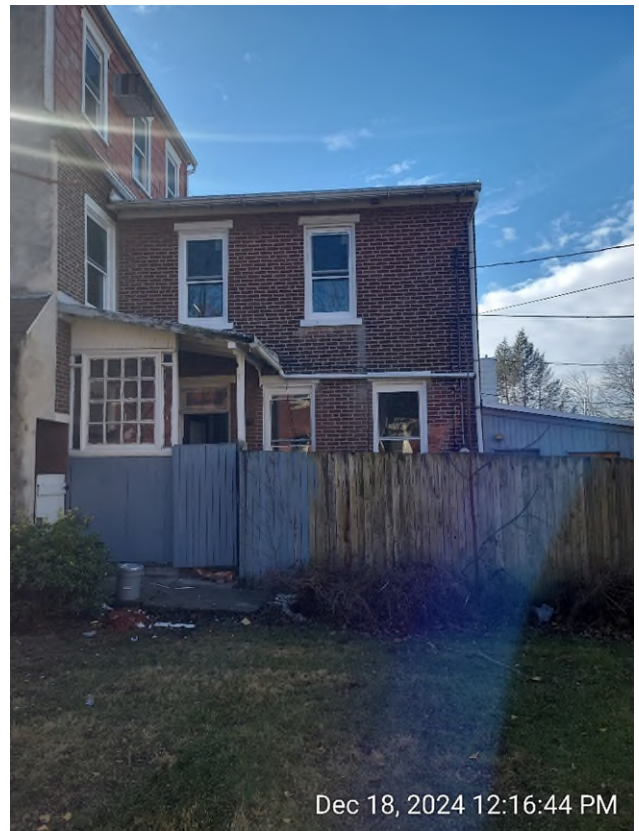
**Fountain Street Elevation (City of Allentown)**

**Project Description:** Legalization of the installation of 12 Magnum 2000 High Performance vinyl windows along Turner Street and along N. Fountain Street. Installation of tempered glass in the front main door.
