HISTORIC ARCHITECTURAL REVIEW BOARD
CITY OF ALLENTOWN
November 12, 2021
FINAL REVIEW

Property located at: 322 N 8th St

Case: HDC-2021-00029

1. Replacement of existing slate roof with new asphalt shingles (two-proposed options)

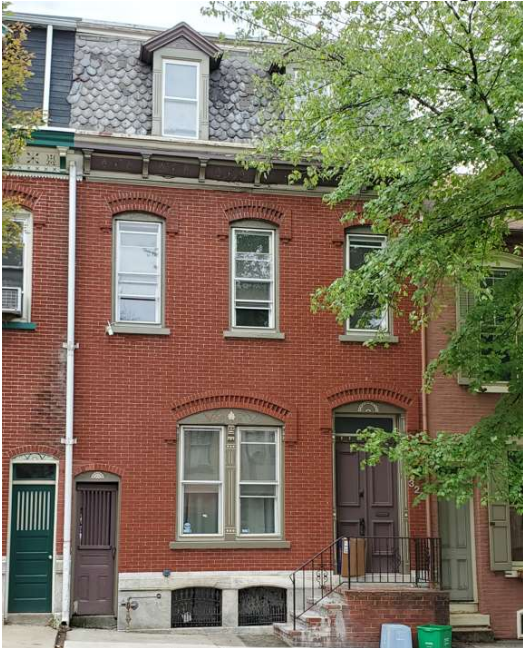
This 3-story Philadelphia brick row home, ca. 1887, in the Eastlake style. The mansard roof displays scalloped slate and 2 dormers. The 1/1 sash in the dormers have projecting moldings. The small peak of the gable roof on each dormer is incised with an Eastlake pattern. Between the 2nd and 3rd floors is a bracketed cornice with a stenciled frieze. The 1/1 sash on the 2nd floor have arched frames incised with a geometric design. The window openings are topped by large segmental brick arches with brick panel of drape is shown at the sides of the arch and is part of the lintel. The 1st floor window consists of two 1/1 sashes with a projecting molding as a divider. Both windows are set into 1 arched and incised frame. The segmental arch lintel with the corbelled panels is the same as the smaller lintels on the 2nd floor. This same ornate style lintel and arched frame tops the paneled double door and transom. Projecting moldings are seen on the door frame. The slatted grocer's alley door has a small transom. It is set into a curved and incised frame with a small segmental brick lintel. The stoop and steps are made of bricks and have a wrought iron railing. There are 2 basement window grilles visible.
