**Historical Architectural Review Board
COA Final Review Sheet**

HDC-2024-00004

Address: 23 N 12th Street

Proposal: Replace roof

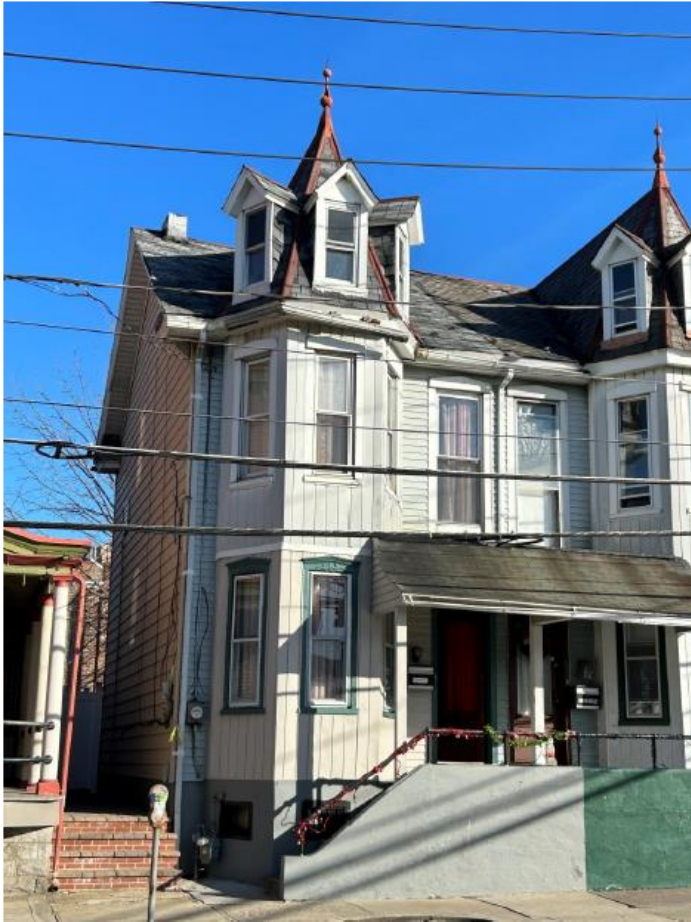
Building Description: This structure is a 2 ½ story, semi-detached frame dwelling with a variety of non-original sidings, gable roof with front corner tower-roof with 3 small dormers, rear shed-roofed dormer, rolled metal ridge caps and finial on the tower roof, 2-story front bay, 1 over 1 double hung windows, and shared front entry porch and curved roof. There is a rear 2 story ell with lower sloped shed roof. The ell is not visible from the front and barely visible from the rear. The house dates from the late 19th century and is altered Queen Anne in style.

Front of 23 N 12th Street
(applicant)

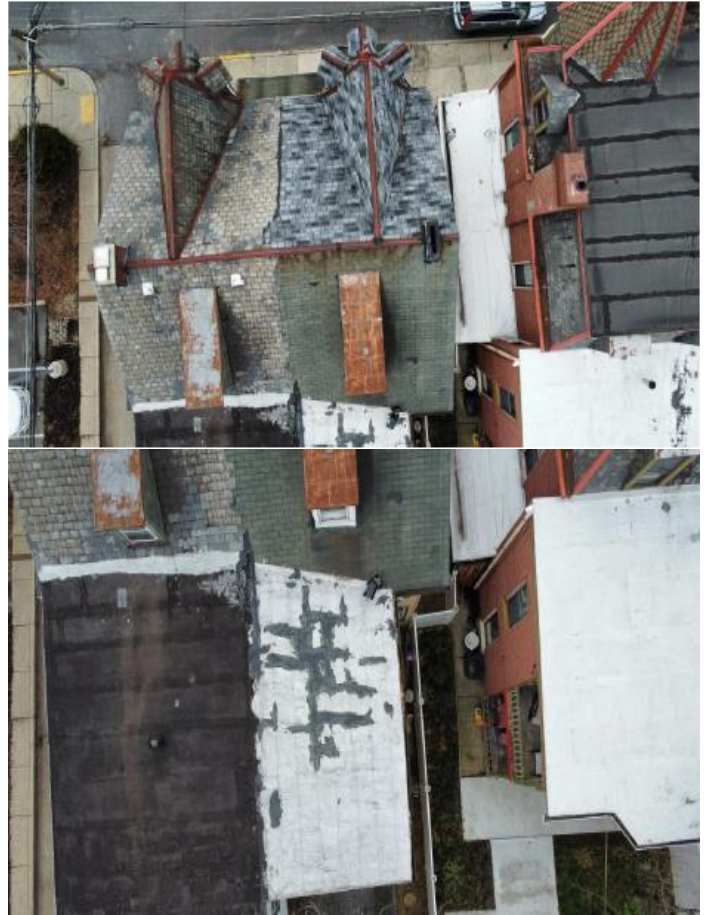
Current roof condition
(applicant)

Observations & Comments: Google Streetview from 2014 shows slate roofing on the gable roof and tower roof but the later satellite views shows replacement shingle roofing. Rolled metal ridge caps are still on the roof. Replacement of existing asphalt shingles on the gable roof and tower roof with new GAF Slateline shingles in the Antique Slate color would be historically appropriate. New or refurbished rolled metal ridge caps should be installed on the roof edges of the tower roof and dormers. The existing historic finial must be retained, repaired in needed, and reinstalled. It is recommended to paint the rolled ridge caps and finial in a matching red color (Tinner's Rd)

Staff Recommendation: Recommend approval as submitted with the condition that metal rolled ridge caps are refurbished and reinstalled or replacement in-kind. The finial must be retained, repaired, and reinstalled.

- The existing metal rolled ridge caps will be refurbished and reinstalled or replaced in-kind
- The finial will be retained, refurbished, and reinstalled.
- Half round gutter will be installed with hangers appropriately mounted at the bottom of the sheathing
- Snow catchers will be retained and reinstalled
- A shingled cap will be installed at the joint between the neighboring roofs.
