# **Historical Architectural Review Board COA Final Review Sheet**

HDC-2023-00016

Address: 616 N. 6th Street

Proposal: Legalize tile on front porch (violation correction)

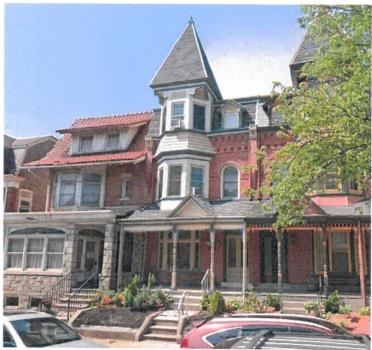
This application seeks to legalize the installation of tile on the front porch of the property at 616 N. 6<sup>th</sup> Street. The porch historically had tongue and groove wood floorboards and was changed to concrete at some point in the past. The tile was installed over the concrete between 2017 and 2018. At the time, a new railing was also installed, though the railing has since been removed.

Detail of porch, 2023. (City of Allentown)

Guideline 3.7.8 notes that alternate porch materials, such as composite wood decking, may be appropriate if similar to the appearance of the original floorboards. The guideline specifically notes that ceramic tile, carpet, or cementitious coatings over wood are not appropriate floor materials. Staff contends that the tile is not an appropriate porch material whether installed over wood or concrete and recommends removing the tiles and repairing the existing concrete slab to better comply with the design guidelines.

Denial, pursuant to Chapter 3, Section 3.7 Porches & Steps.

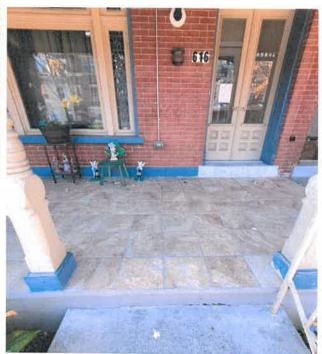
Detail of porch, 2023. (City of Allentown)
