**CITY OF ALLENTOWN
HISTORIC ARCHITECTURAL REVIEW BOARD
FINAL REVIEW SHEET
January 10, 2018**

Case #HDC-2018-00040– Proposal to continue installation of the satellite dish installed on the front of the building.

Property located at: 425 N 10th Street
Agenda #1
Historic District: Old Allentown
Case # HDC-2018-00040
Meeting date: January 7, 2019

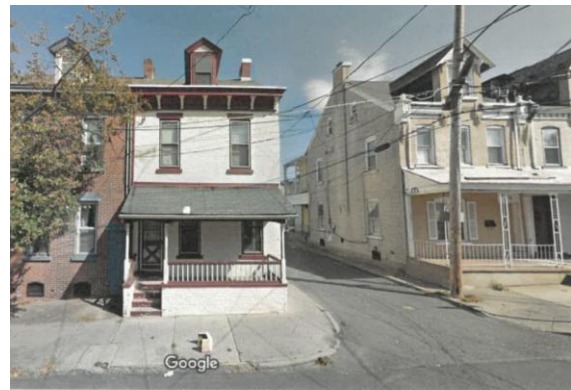
Allentown, Pennsylvania
Google, Inc.
Street View - Oct 2014

Building description, period, style, defining features: This structure is a 2 bay, 2 ½ story painted end-of-row brick dwelling with gable roof, dormer, projecting bracketed cornice, 1 over 1 double hung windows with carved Eastlake lintels, full front porch and full front porch with turned posts and square balusters. The building dates from c. 1895 and is Eastlake in style.

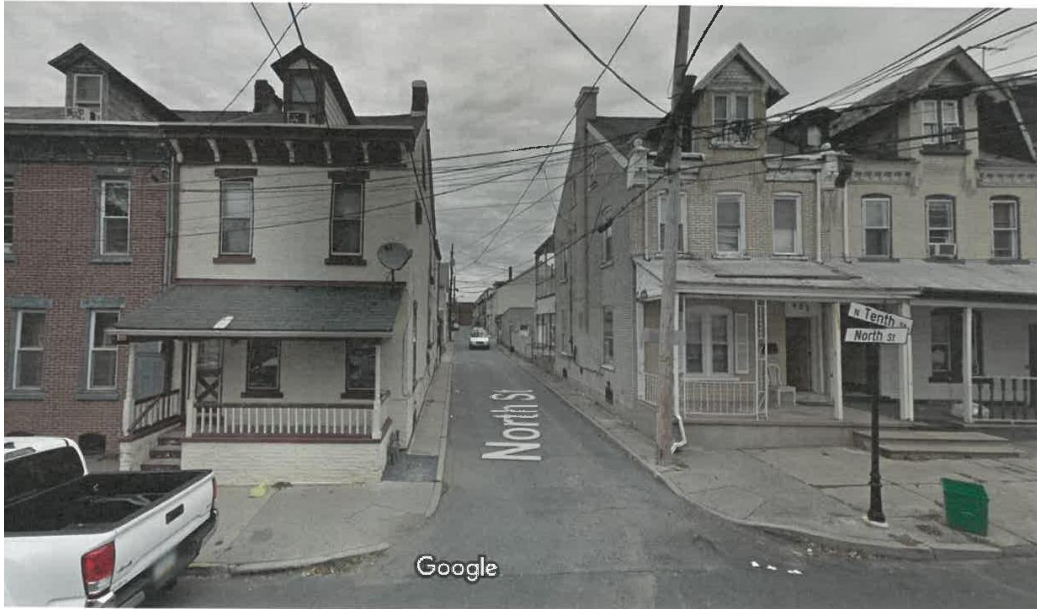
Street View - Sep 2017

December 5, 2018 – Satellite dish installed on front of building.

-Mounting mechanical, electrical, and communications equipment and devices on a primary façade is not appropriate.

Evaluation, effect on historic district, recommendations: The dish should be removed and relocated to a less visible side (rear).

1. The proposal to continue the installation of a satellite dish on the front of the building at 425 N 10th Street was not represented.
2. The installation is a clear violation of the historic design guidelines and must be removed from the front façade.
3. The satellite dish should be relocated to one of the rear flat roof areas of the building not visible from the street.
