**CITY OF ALLENTOWN
HISTORIC ARCHITECTURAL REVIEW BOARD
FINAL REVIEW SHEET
January 10, 2018**

Case #HDC-2018-00040– Proposal to continue installation of the satellite dish installed on the front of the building.

Property located at: 425 N 10th Street

Case # HDC-2018-00040

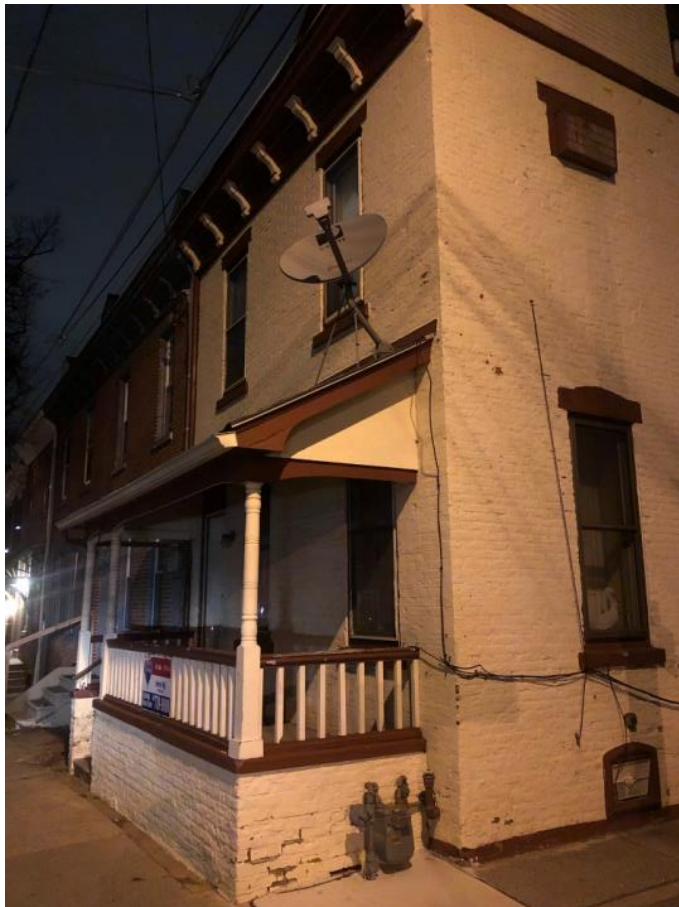
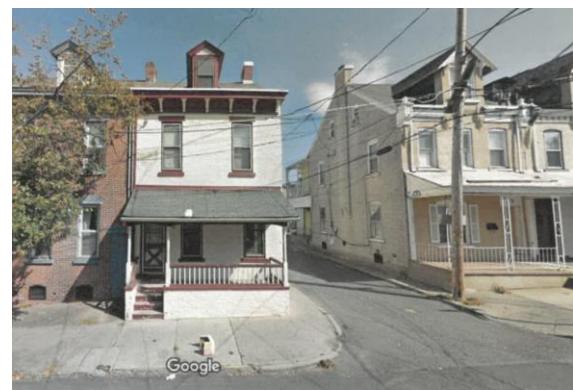
Allentown, Pennsylvania
Google, Inc.
Street View - Oct 2014

Building description, period, style, defining features: This structure is a 2 bay, 2 ½ story painted end-of-row brick dwelling with gable roof, dormer, projecting bracketed cornice, 1 over 1 double hung windows with carved Eastlake lintels, full front porch and full front porch with turned posts and square balusters. The building dates from c. 1895 and is Eastlake in style.

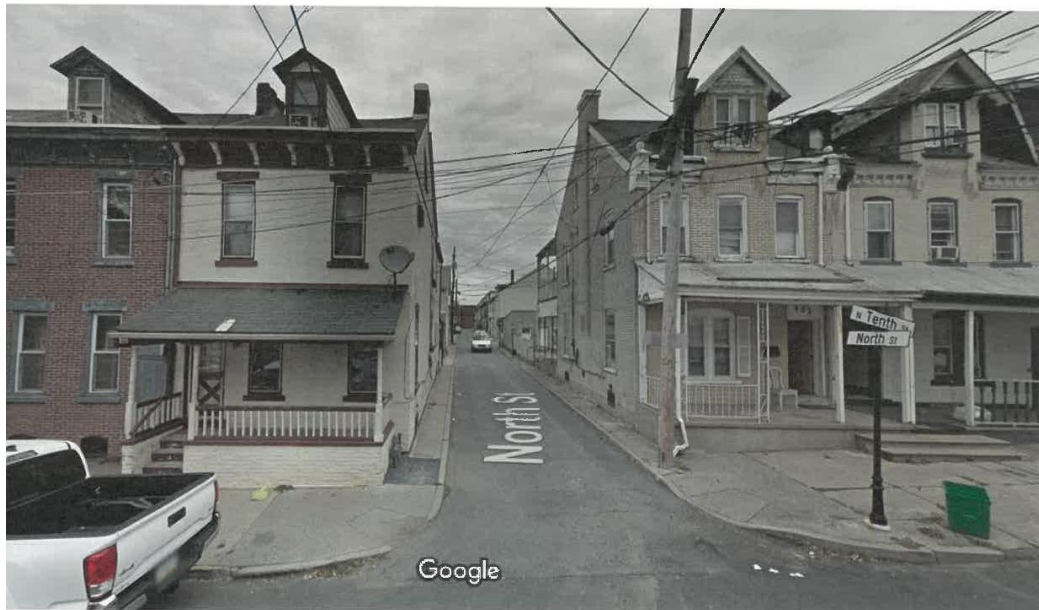
Street View - Sep 2017

Proposed alterations: It is proposed to continue installation of the satellite dish installed on the front of the building.

December 5, 2018 – Satellite dish installed on front of building.

Evaluation, effect on historic district, recommendations: The dish should be removed and relocated to a less visible side (rear).

1. The proposal to continue the installation of a satellite dish on the front of the building at 425 N 10th Street was not represented.
2. The installation is a clear violation of the historic design guidelines and must be removed from the front façade.
3. The satellite dish should be relocated to one of the rear flat roof areas of the building not visible from the street.
