**HISTORIC ARCHITECTURAL REVIEW BOARD
CITY OF ALLENTOWN, PENNSYLVANIA
June 3, 2019
FINAL REVIEW - DENIAL**

Item #1 - Case # HDC-2019-00010 – Proposal to rehabilitate and reconstruct front porch including flooring, posts, and roof

Property located at: 537 W Liberty Street

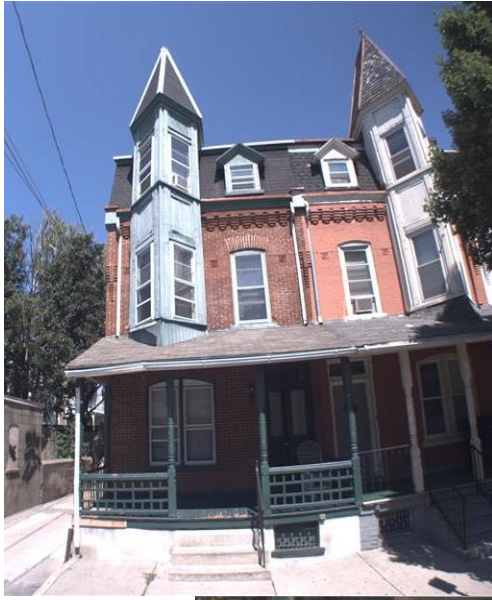
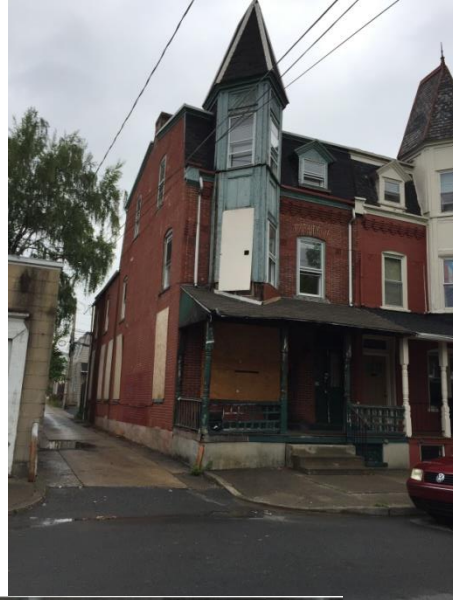
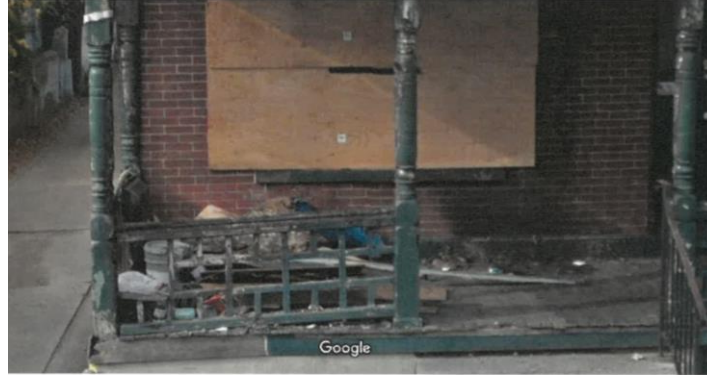
Allentown, Pennsylvania
Google
Street View - Oct 2018

Building description, period, style, defining features: This 3-story brick row house, ca 1893 is Queen Anne in style. There is a unique triangular projecting tower that extends from the 2nd to 3rd floor with paneled exterior and a character defining roof shape. The house has a mansard roof with asphalt shingles, a single dormer to the right of the tower and brickote on the side. The windows are 1/1 sash with segmentally arched brick headers. The main entry is a single door with transom on a wooden porch with turned posts and character defining geometric wood railing.

Proposed alterations: It is proposed to rehabilitate and reconstruct front porch including flooring, posts, and roof. From photos that were submitted, it appears that new 6x6 PVC “Colonial” style posts are proposed that are close but not matching the historic posts that were damaged in a porch fire; new 1x6 T&G beaded board proposed for the ceiling; 1x4 T&G fir flooring proposed for the porch floor; and charcoal gray “architectural” style shingles proposed for the roof.

Evaluation, effect on historic district, recommendations: The proposed repair of the deteriorated porch is historically appropriate in approach but not in all details. The beaded board ceiling and fir porch flooring are historically appropriate and should be painted. The proposed turned posts and shingles should be modified if possible. The PVC posts are too narrow at the turned section – a better selection and material should be sought. It is also recommended to keep posts that are not damaged or have minimal damage and replace only the corner post if possible. In that case creating a replica of the original post made might be cost effective and would be more historically appropriate. The roof should be a flat 3 tab shingle or GAF Slateline (or equivalent) shingle in charcoal gray not the architectural shingle as proposed. Repairs to the roof fascia/soffit and porch structure should be done in wood and match the existing in dimension and detail. The railing/guards should replicate the existing historic wood railing guards. The height of the railing/guards should be able to be maintained under the IEBC since the building is a certified historic building.
