**HISTORIC ARCHITECTURAL REVIEW BOARD
CITY OF ALLENTOWN, PENNSYLVANIA**

**August 5, 2019
FINAL REVIEW**

Item #2 - Case # HDC-2019-00035 – Proposal to renovate the building

Property located at: 532 Law Street

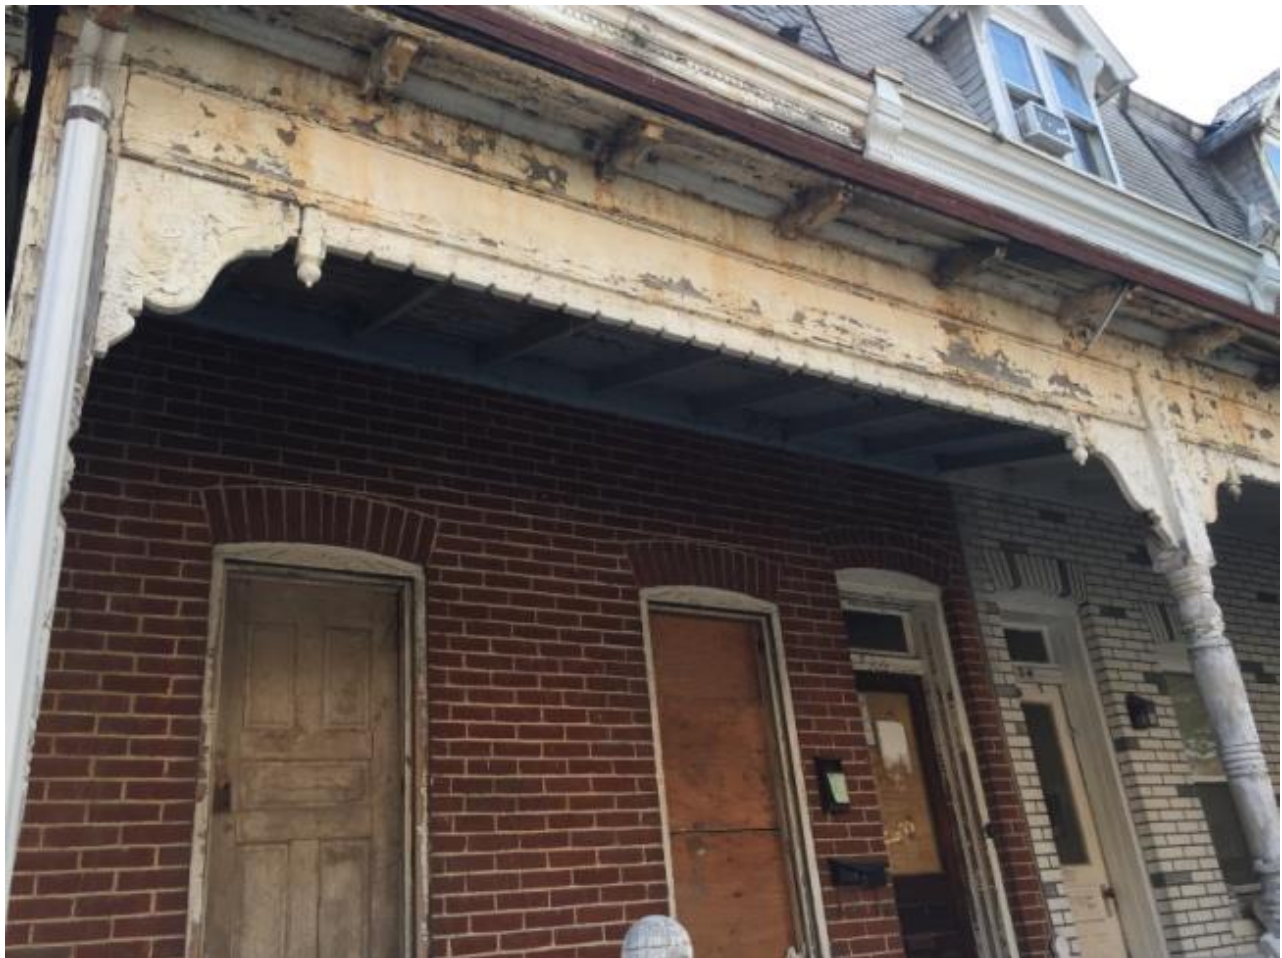
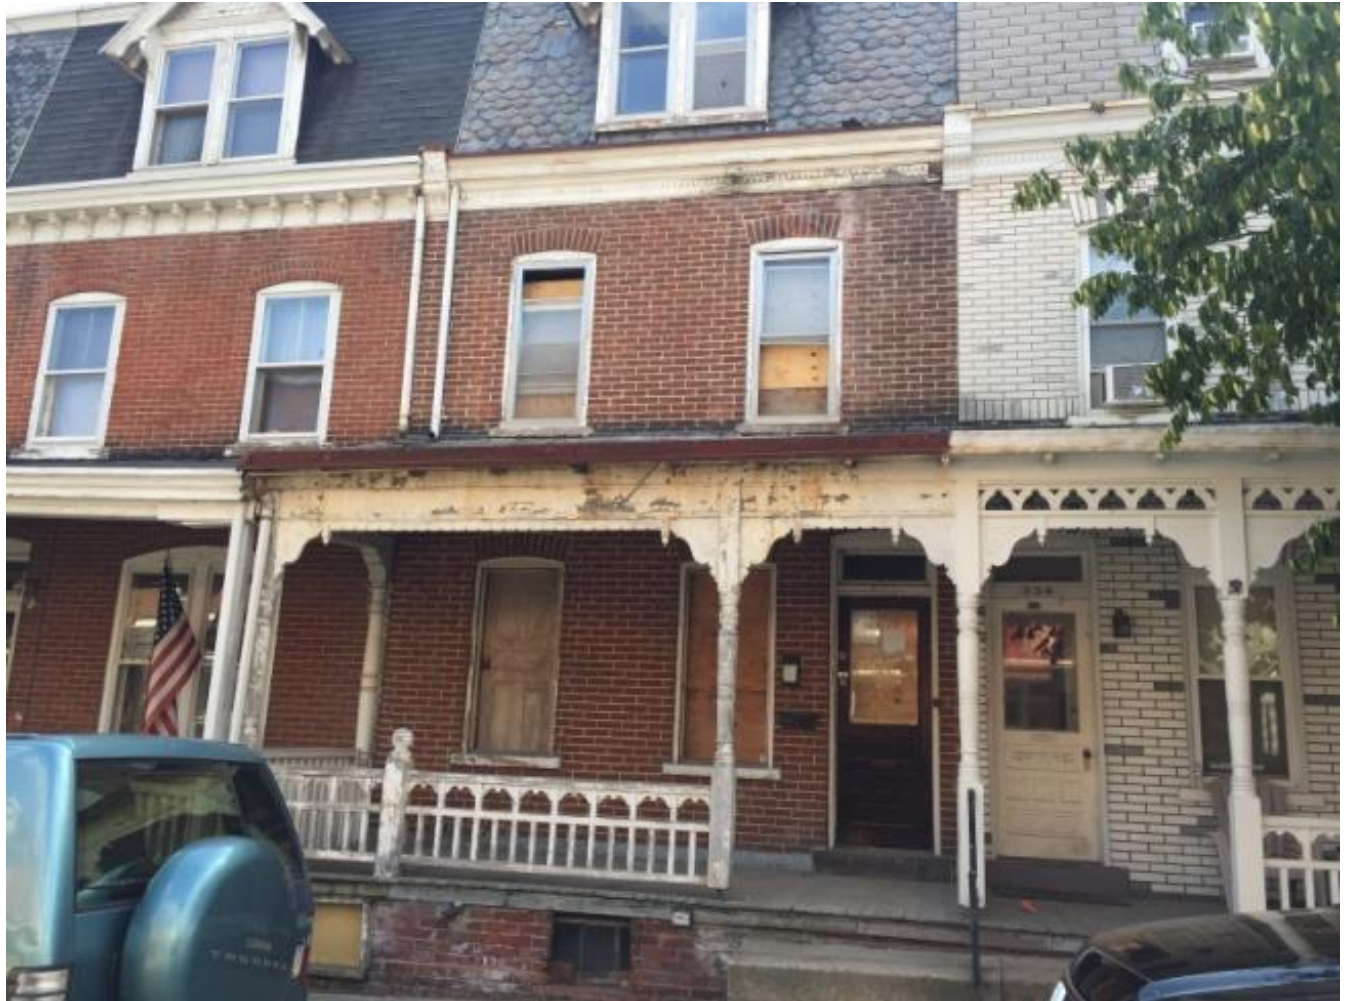
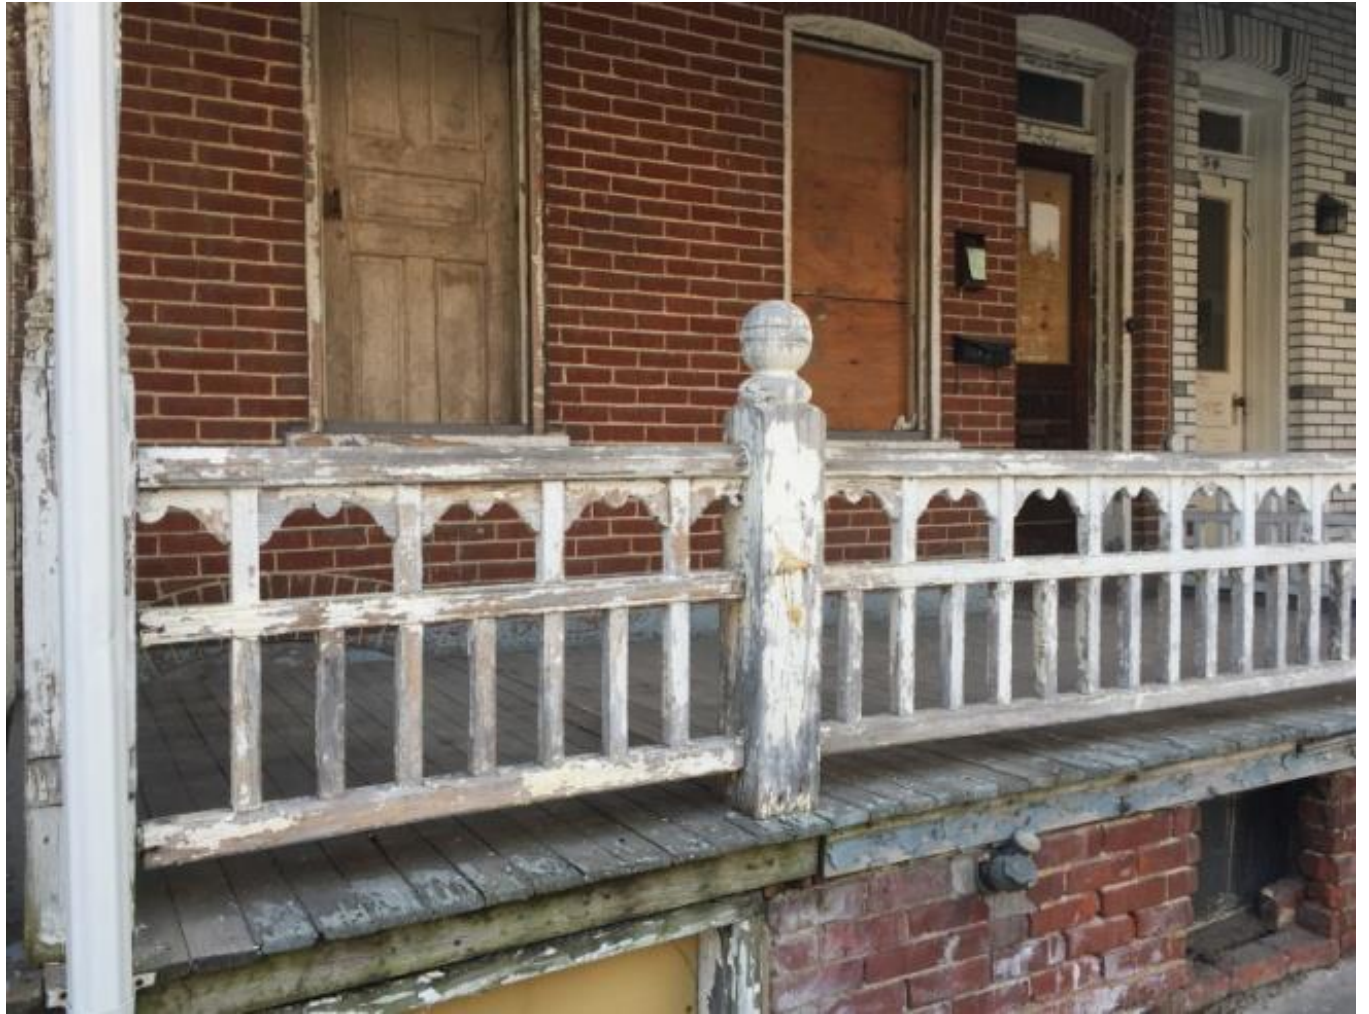
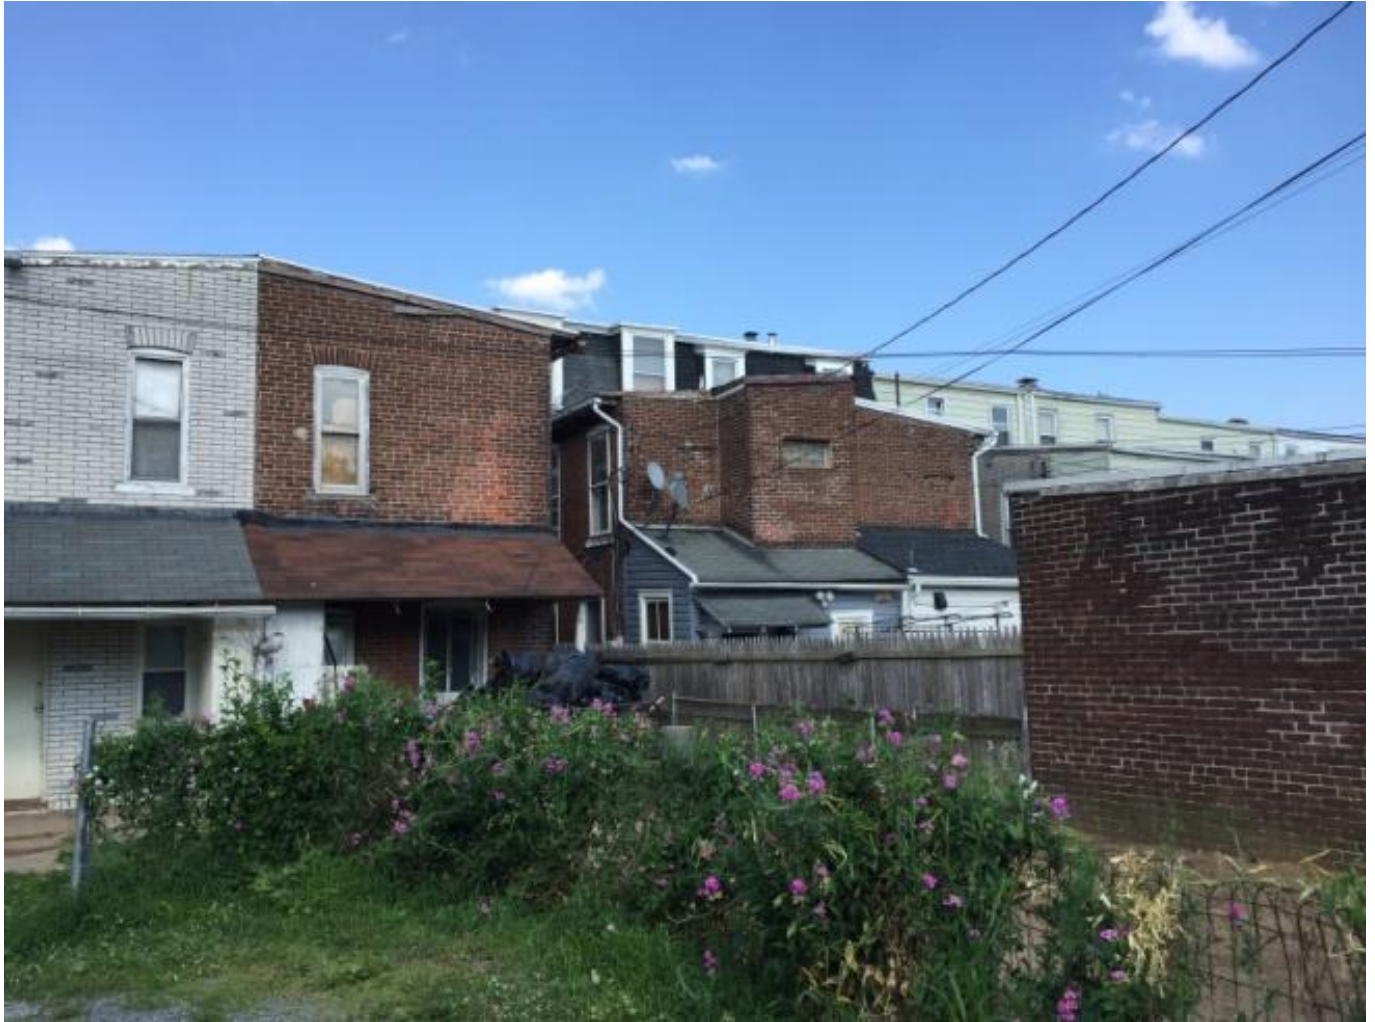
Building description, period, style defining features: This structure is a 3 story attached red brick dwelling with a Mansard roof, dormer with paired 1/1 double hung windows, segmentally arched masonry openings with 1/1 double hung windows, and a full front porch with decorative brackets, unique wood railings and turned porch posts. The house dates from the late 19th century and is Queen Anne in style. The house, although in deteriorated condition, has a high level of historic integrity.

Evaluation, effect on historic district, recommendations: The general renovation approach is historically appropriate, but a number of the items described in the contractor contract and specifications need to be modified or clarified:

1. The front and rear porches have pitches that appear steep enough for shingles. Fiberglass shingles (3-Tab or GAF Slateline or equivalent in antique slate color) are recommended. It is not clear why insulation is specified for the porch roofs – the added thickness is not historically appropriate.

2. It is also not clear why the front porch needs to be reframed. If necessary, the new framing must not alter the historic woodwork, built-in gutter, or the exposed roofing boards

3. New windows must be aluminum clad wood windows not vinyl clad wood windows. The windows were 1/1 double hung and the neighboring properties all have 1/1 double hung windows. The new windows should be 1/1 double hung. No divided lights needed.

4. The basement windows should also be aluminum clad or full aluminum. Single light hopper windows would be historically appropriate as well as installing a salvaged iron grate. Brick repairs around the basement windows should follow Preservation Brief #2

5. Rear basement Bilco style door is not highly visible.
6. The existing front door should be retained and repaired.
7. Light fixture specification should be submitted for approval by staff

8. Existing built-in gutters on the front of the house should be retained, rebuilt as needed, and lined with new EPDM or copper. Half round gutter would be historically appropriate at the rear of the building.

9. The front slate mansard needs repair or replacement. If repair is not possible, the slate could be replaced with real slate or a fiberglass shingle with a similar scalloped shape such as CertainTeed Carriage House shingle in a slate gray color (or equivalent).

10. This house is the mirror of 534 Law St. The porch fascia on 532 Law St may be identical to 534 and it should be investigated if the current flat board is laid over open work matching 534. If so, removal of the flat board is recommended.
