**Certificates of Appropriateness for work in the Historic Districts:
532 Law Street.**

**HISTORIC ARCHITECTURAL REVIEW BOARD
CITY OF ALLENTOWN, PENNSYLVANIA
August 5, 2019
FINAL REVIEW**

Item #2 - Case # HDC-2019-00035 – Proposal to renovate the building

Property located at: 532 Law Street

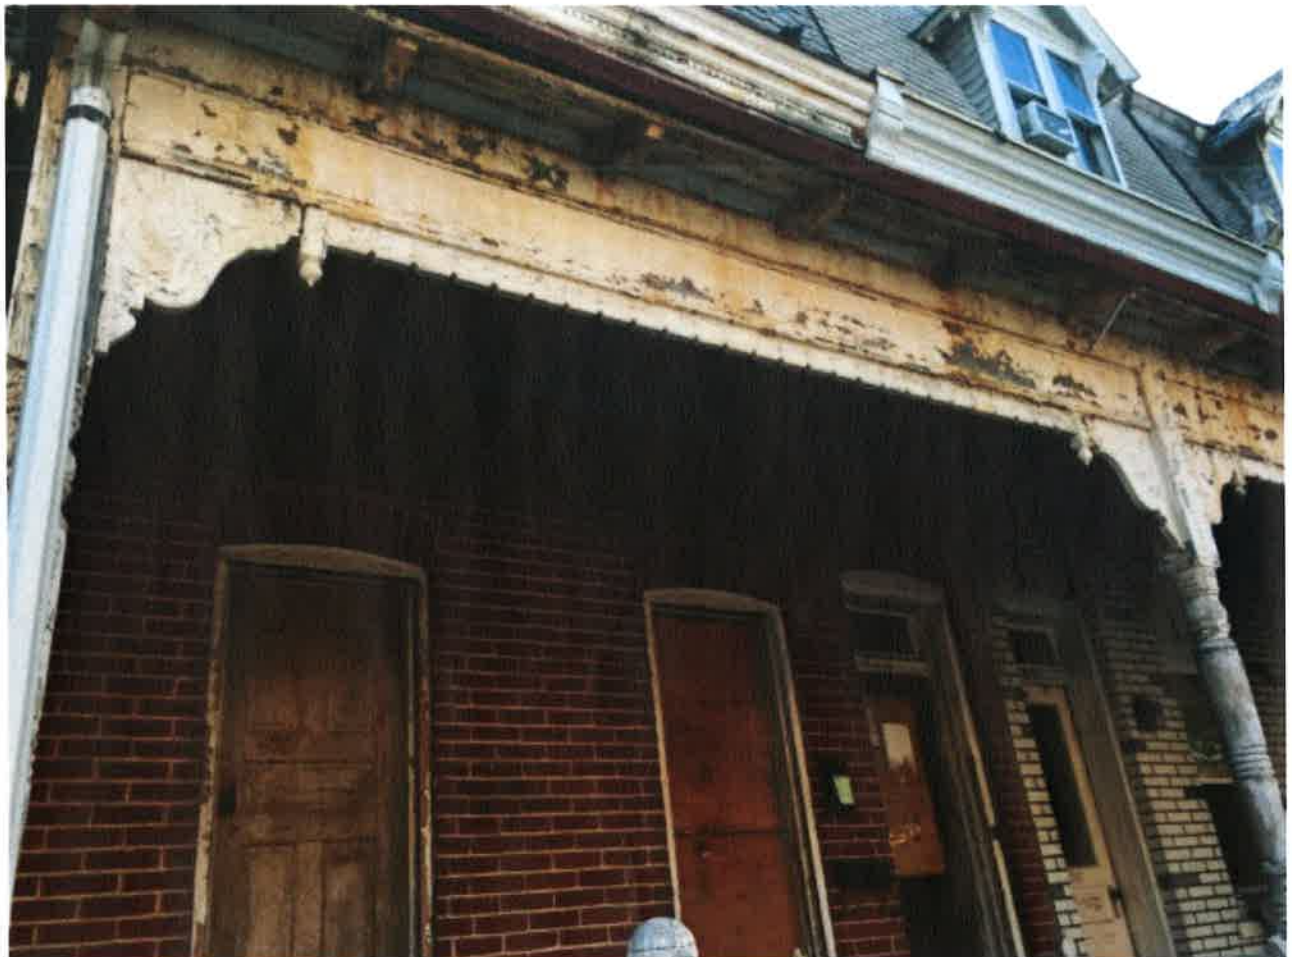
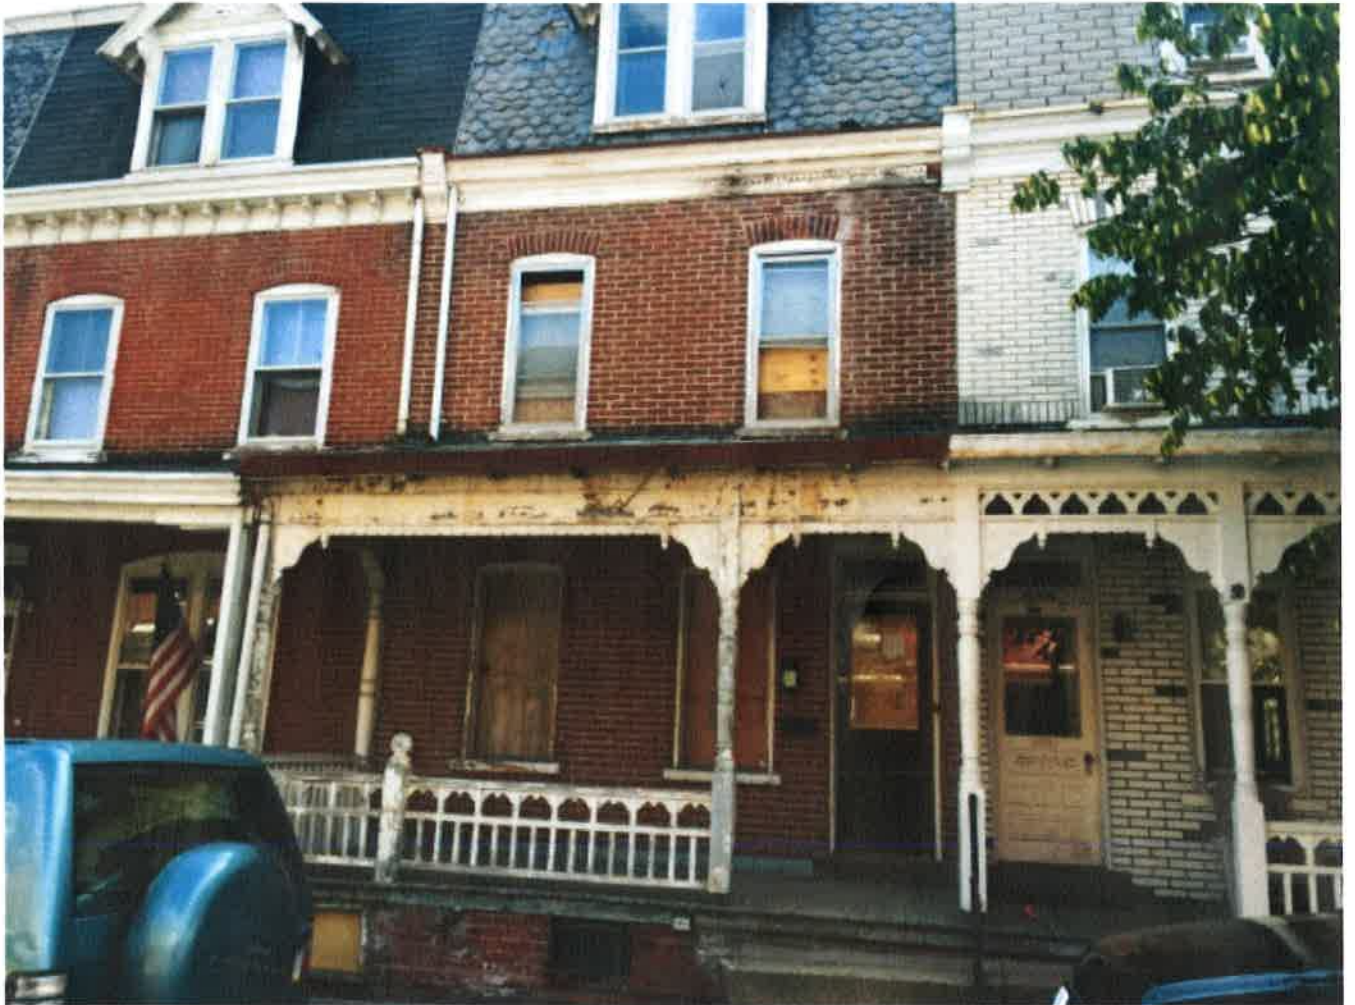
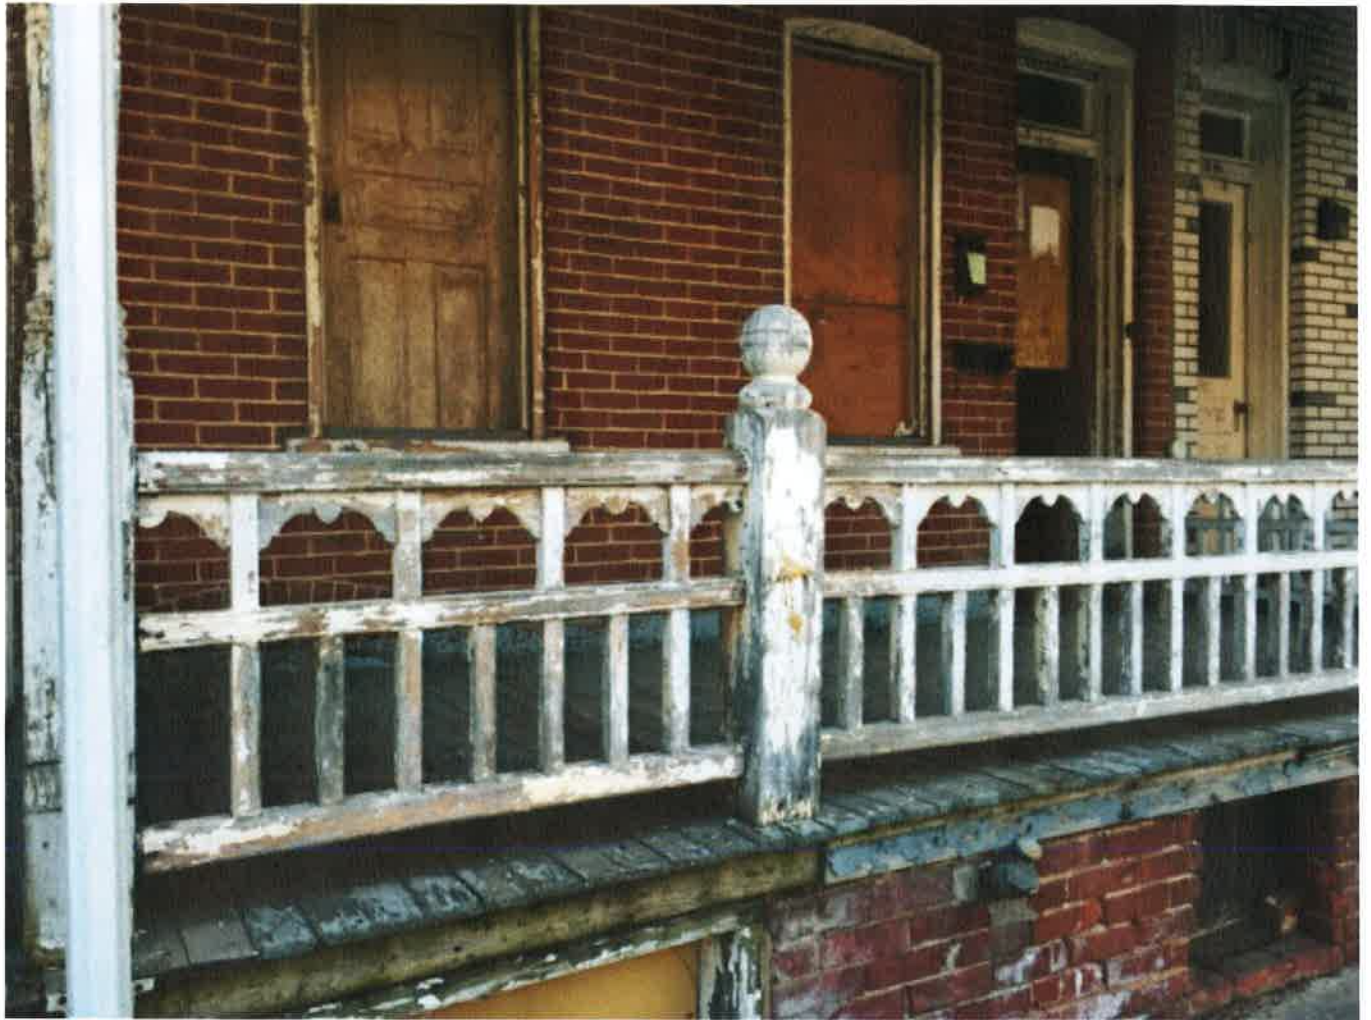
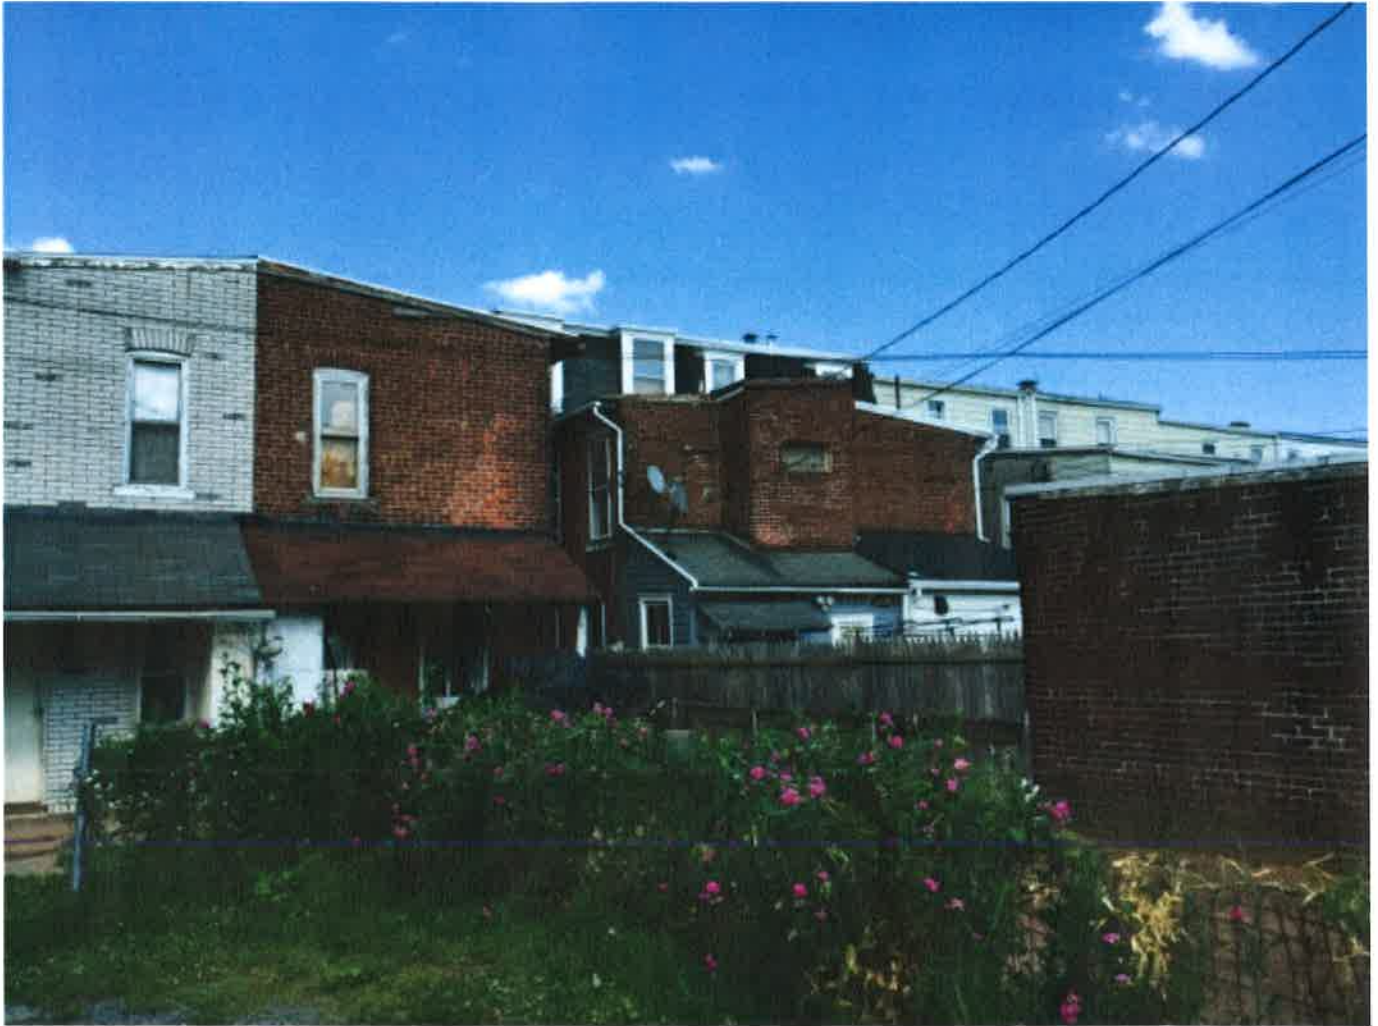
Building description, period, style defining features: This structure is a 3 story attached red brick dwelling with a Mansard roof, dormer with paired 1/1 double hung windows, segmentally arched masonry openings with 1/1 double hung windows, and a full front porch with decorative brackets, unique wood railings and turned porch posts. The house dates from the late 19th century and is Queen Anne in style. The house, although in deteriorated condition, has a high level of historic integrity.

1. The front and rear porches have pitches that appear steep enough for shingles. Fiberglass shingles (3-Tab or GAF Slateline or equivalent in antique slate color) are recommended. It is not clear why insulation is specified for the porch roofs – the added thickness is not historically appropriate.

2. It is also not clear why the front porch needs to be reframed. If necessary, the new framing must not alter the historic woodwork, built-in gutter, or the exposed roofing boards

3. New windows must be aluminum clad wood windows not vinyl clad wood windows. The windows were 1/1 double hung and the neighboring properties all have 1/1 double hung windows. The new windows should be 1/1 double hung. No divided lights needed.

8. Existing built-in gutters on the front of the house should be retained, rebuilt as needed, and lined with new EPDM or copper. Half round gutter would be historically appropriate at the rear of the building.

9. The front slate mansard needs repair or replacement. If repair is not possible, the slate could be replaced with real slate or a fiberglass shingle with a similar scalloped shape such as CertainTeed Carriage House shingle in a slate gray color (or equivalent).

10. This house is the mirror of 534 Law St. The porch fascia on 532 Law St may be identical to 534 and it should be investigation if the current flat board is laid over open work matching 534. If so, removal of the flat board is recommended.
