**HISTORIC ARCHITECTURAL REVIEW BOARD  
CITY OF ALLENTOWN, PENNSYLVANIA  
February 13, 2019  
FINAL REVIEW**

**Case # HDC-2020-000001** - Proposal to continue the installation of vinyl windows on the front and side of house visible from the public right of way.

**Property located at:** 214 N Fountain Street

**Historic District:** Old Allentown

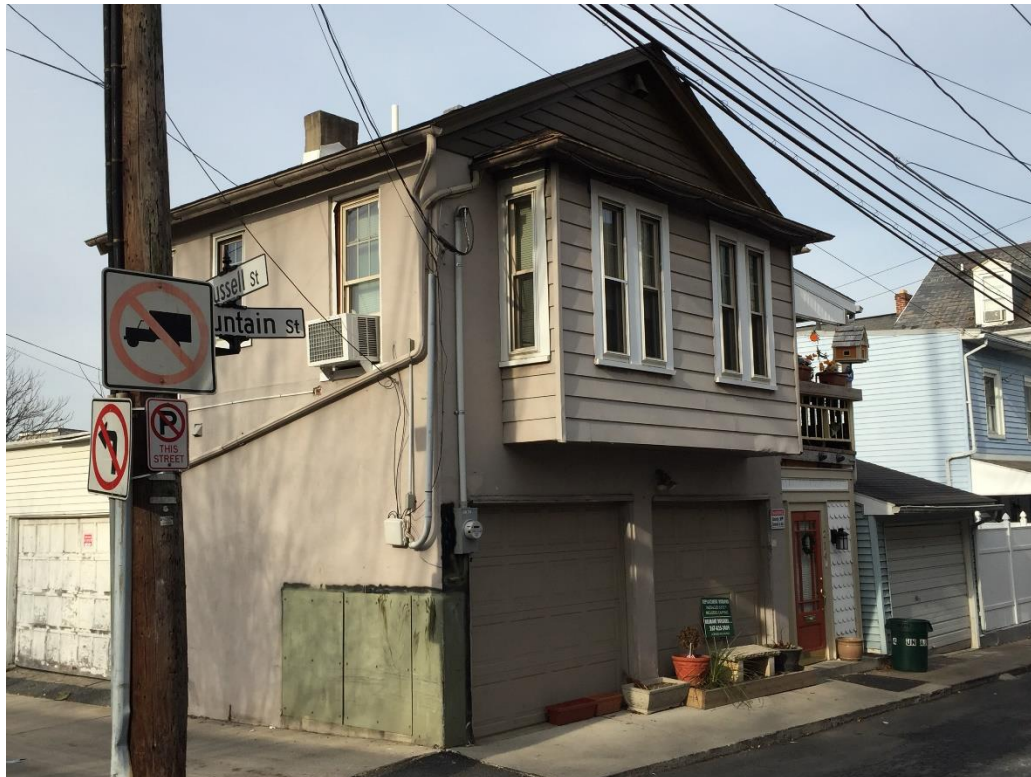
**Building description, period, style defining features:** This structure is a 2 ½ story masonry dwelling above a garage with stucco walls, projecting box bay on the second floor front with aluminum siding, front-facing gable roof, a side entry with porch above on the second floor, and vinyl window replacements. The building dates from c.1920-1930 and is utilitarian in style. The vinyl windows were installed without HARB review.

**Proposed alterations:** It is proposed to continue the installation of vinyl windows on the front and side of house visible from the public right of way. The vinyl windows have grills between the glass on the upper sashes except for the narrow window on the side of the box bay. Existing storm window frames remain but the storm window sashes appear to have been removed.

**Evaluation, effect on historic district, recommendations:** It is not easy to see what type of windows were previously in the building from older Street Views (back to 2008). Wood windows should have been retained and repaired. Vinyl windows do not meet the design guidelines are not historically appropriate, but in this case they were at least installed to fit the size of the existing window openings. It should be determined what the previous windows were. The existing context is an alley of about 25% garages and the rest narrow row houses, some restored. There appears to be a predominance of vinyl windows in block. If the HARB decides the windows are acceptable in this mixed use building in this context, it is recommended that the triple track storm window frames be removed to improve the historic appearance of the building.

2. The installation of almond color vinyl windows with grills between the glass are permitted on the front and side of house due to the building being highly altered and not a contributing resource in the district. It was also not clear what the material of the previous windows were.
  3. The storm window frames must be removed.
  4. The vinyl scalloped shingle siding on the "security" wall must be painted to match the other wall color of the house using proper primer and paint for vinyl.
  5. The remedial work must be completed by April 30, 2020.
- The proposal to issue a COA was unanimously approved. (6-0; motion carried; Brobst, Fillman, Huber, Olson, Roberts, Sell)
