**HISTORIC ARCHITECTURAL REVIEW BOARD
CITY OF ALLENTOWN, PENNSYLVANIA
May 4, 2020**

FINAL REVIEW

Case # HDC-2020-0000x - Proposal to continue the removal of windows, including stain glass windows, and installation of new windows.

Property Location:	231 N 8 th Street	Property Owner:	Luis Hernandez
Historic District:	Old Allentown	Owner Address:	231 N 8 th Street, Allentown, PA 18102
Case #	HDC-2020-	Applicant:	(Same as Owner)
HARB Meeting date:	May 4, 2020 (Agenda Item #2)	Applicant's Address:	(Same as Owner)

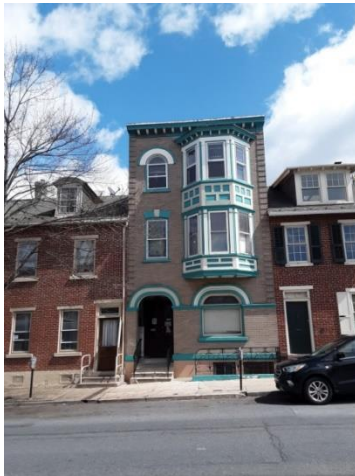
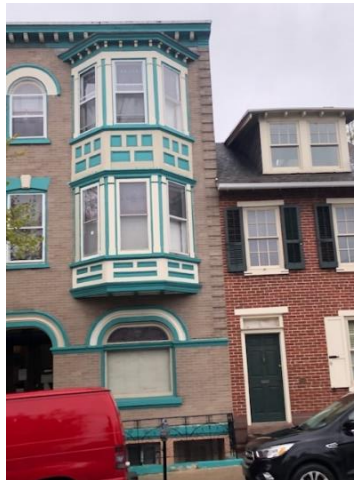
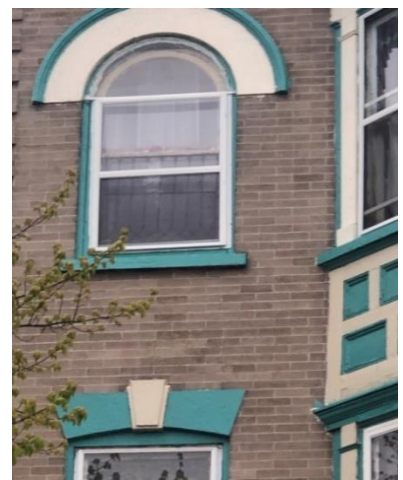
Building description, period, style defining features: This structure is a 3 story, tan brick, attached residential building with a flat roof, bracketed cornice, round arch third floor window, two story oriel windows, basket arches on the first floor doorway and window, and multiple stain glass windows. The building is Italianate in style and dates from the late 19th or early 20th century. The building has a high level of historic integrity.

HARB Discussion: The applicant said he took the windows sashes out to paint and has reinstalled them. It was pointed out that the stained glass sash upper sash on the third floor was not reinstalled. Photos from 2014 showed the stained glass sash was there at that time. The applicant has owned the property since 2012. Mr. Kimmerly said he thought it was an old violation. The HARB asked the applicant to install a stain glass arched upper sash. The new sash stained glass should be designed to be similar to the remaining stained glass sashes and as seen in older photos. Mr Fillman pointed out that there was a problem with the storm window installation on the third floor arched window – the meeting rails did not align with the historic windows.

1. The proposal to continue the removal of windows, including stain glass windows, and installation of new windows at 231 N 8th Street was represented by Luis Hernandez.
2. The missing leaded glass arched window sash will be fabricated and installed to match original.
3. The storm window will be removed from the same window and a new arched storm window will be installed with meeting rails aligning with the historic window.
4. Other windows will remain in place and be painted.
