**HISTORIC ARCHITECTURAL REVIEW BOARD
CITY OF ALLENTOWN, PENNSYLVANIA
June 1, 2020**

FINAL REVIEW

Address: 302 N 9th Street –

- Proposal to continue the installation of the window signs that are a violation of the historic district ordinance (Disapproved by HARB on May 4)
- Proposed new design for window signs (Approved by HARB on June 1)

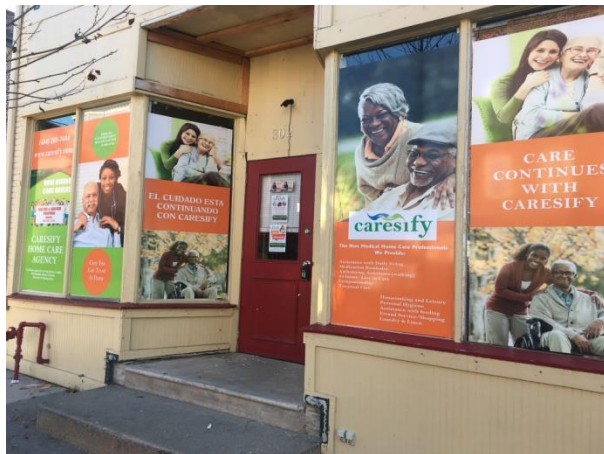
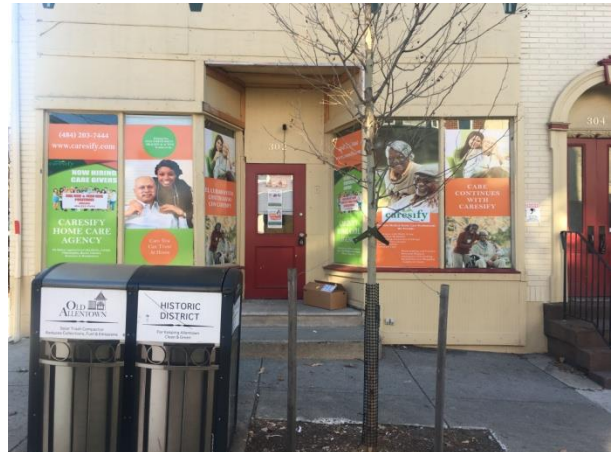
Building description, period, style defining features: This structure is a 3 bay, 3 story, painted brick, semi-detached mixed use building with a bracketed projecting cornice, shallow gable roof, rear flat-roofed rear extension, 1 over 1 double-hung windows, two side oriel windows, and an altered storefront. The building dates from c. 1880 and is Italianate in style. The building has a moderate level of historic integrity. The storefront is in deteriorated condition.

Proposed alterations: It is proposed to install window signs that are a violation of the historic district ordinance.

The Design Guidelines state that signs located in historic districts must be compatible with and appropriate for the style and character of the historic building. Signs should not cover or conceal architectural features and must also comply with the City's zoning ordinance, which regulates, among other things, the size of the sign. These signs completely cover the storefront windows which is not historically appropriate. In addition, the area of signage likely does not comply with zoning regulations.

Smaller signs that are placed within the glass area are recommended. The main sign should identify the business name and be the largest sign(s). Business name signs could be on either side of the entry. Secondary signage might list services. It is recommended to remove the large scale images of people.

Scaled drawings of the storefront with new signage should be submitted for review. Sign companies often can provide scaled drawings of sign for approval purposes.

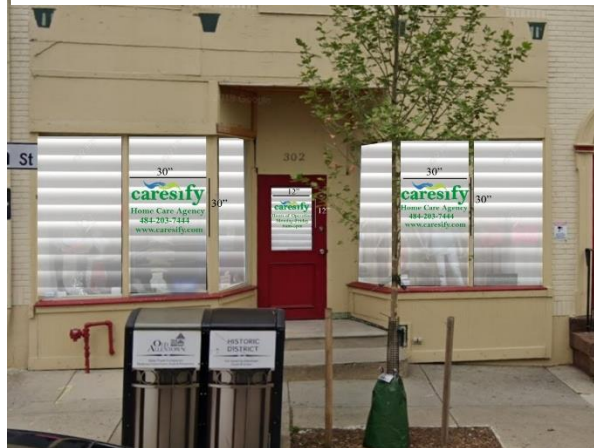
New design submitted and approved on June 1.

June 1, 2020 -- The applicants explained the new proposal was to install mini-blades in the interior of the storefront windows and install vinyl signage on two of the display windows and on the door. The signs on the windows would be 30" wide and 30" high and include the phone number and website. The sign on the door would be 12" x 12" and include the hours of the business. The colors would be green and blue. The HARB agreed that the new proposal was historically appropriate.

1. The proposal to install vinyl signage on the storefront at 302 N 9th Street was represented by Jennifer Doublin and Sheriff Adewale.
2. The new window signs will 30" x 30" and read "caresify, home care agency" in green and blue with phone number and web address.
3. The new door sign will be 12" x 12", similar to the windows signs, and include business hours.
4. Privacy for the business will be provided by interior metal mini blinds.
