**HISTORIC ARCHITECTURAL REVIEW BOARD  
CITY OF ALLENTOWN, PENNSYLVANIA  
June 1, 2020**

**FINAL REVIEW**

**Address:** 405 N 9th St, Allentown (Old Allentown Historic District) -- Proposes to replace the 3<sup>rd</sup> floor wood windows with vinyl to match the vinyl replacement windows previously installed on the 1<sup>st</sup> & 2<sup>nd</sup> floors.

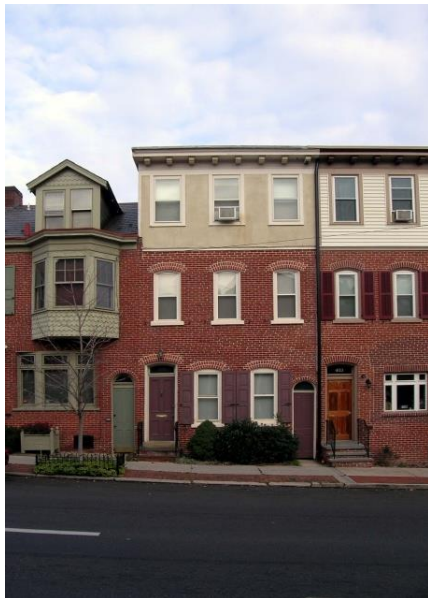
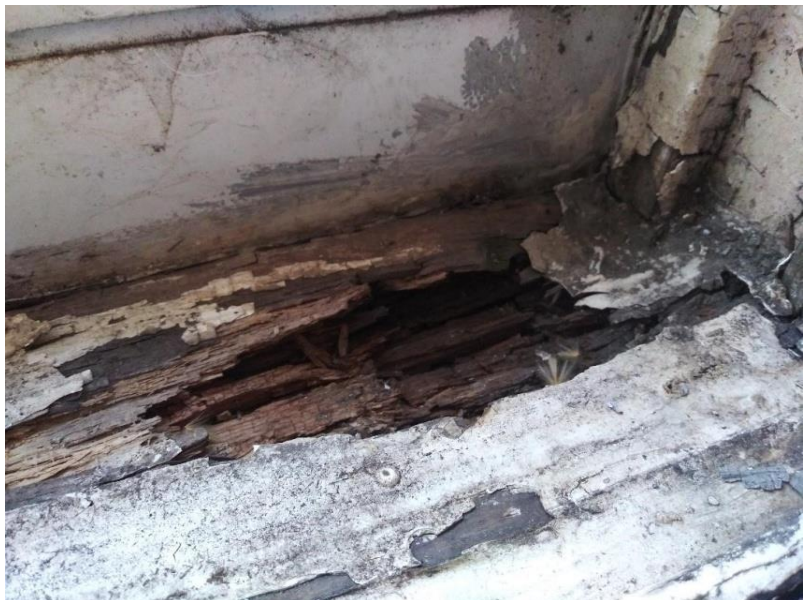
**Building description, period, style defining features:** This structure is a 3 bay, 3 story attached brick and stucco dwelling with very low sloped roof, bracketed cornice, segmentally arched windows on the first and second floors, grocer alley door, and vinyl replacement windows on the first and second floors. The first and second floors appear to be the original building height and the third floor appears to have been a later, but historic, addition. The original part of the building dates from c. 1875 and the third floor addition appears to be early 20<sup>th</sup> century. The building retains integrity.

The submitted photo shows significant deterioration although it is not clear where the photo was taken. If the windows are beyond repair it is recommended to install aluminum clad wood windows (Harvey, Pella, Andersen, or equivalent) or smooth fiberglass or composite window (Andersen, Pella, Marvin or equivalent). The new windows should fit the existing openings without blocking. Window trim and sills should not be capped in aluminum.

Ms Jackson asked the applicant where the photograph submitted was taken. He said it was the interior windowsill. Ms Jackson said she thought the problem appeared to be the sill and not the windows sashes. The applicant asked when the HARB started not allowing vinyl windows on the front façade. The Consultant informed him in 2012 with the publishing of the new historic design guidelines. The HARB members agreed with the consultant that vinyl windows would not be approvable. Aluminum clad and other approvable window materials were reviewed and possible window companies. The applicant said one of the window companies he would never use and got agitated. He said he would just fix and paint the windows and hung up.

1. The proposal to install vinyl windows on the third floor at 405 N 9<sup>th</sup> Street was represented by James Villaume and Dale Fritchman
2. Vinyl windows on front facades are not permitted in the Allentown Historic District Guidelines.
3. The existing wood windows and sills should be repaired and repainted.
