# Historical Architectural Review Board COA Preliminary Review Sheet

**HDC-2025-00024**

**Address:** 1550 Chew Street

**Proposal:** Partial roof replacement

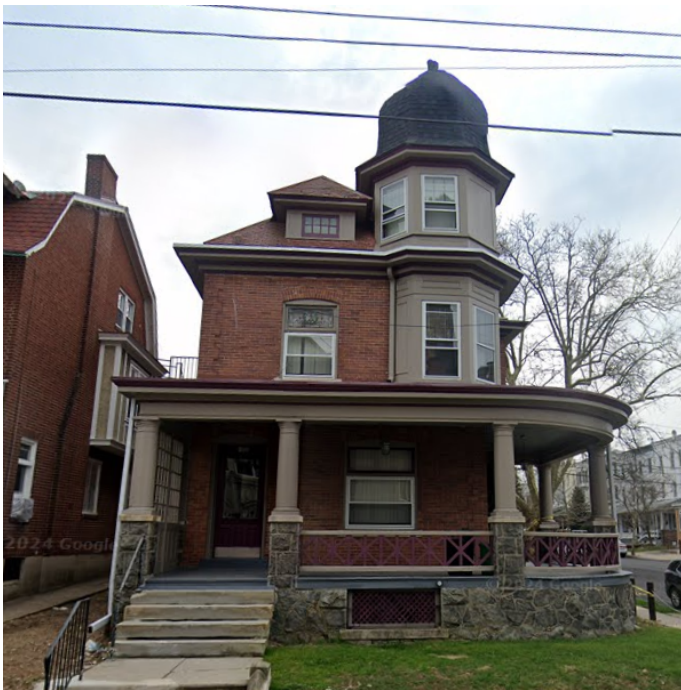
**Building Description:** This brick building is a 2 ½ story Queen Anne/Porch House, built in 1927. It features a corner turret with dome roof and wrap around L-shaped porch with wide columns supporting the porch roof. Many windows are 6 over 1, though there are variations due to varying window sizes.

Existing Front Elevation (Google Maps, April 2024)

**4/7/25 Observations & Comments:** It would be helpful if there were photos or evidence of the condition of the current clay tile roof. The previously performed roof replacements were not in keeping with the guidelines/the original roof; the dark grey/black 3-tab shingle was not an appropriate replacement.

While the building rear and tower roofs were both replaced with a dark asphalt shingle, the view of the primary elevation and the main corner of the building along the streetscape retains the clay tile, consistent with an adjacent cluster of clay tile/red asphalt roofed buildings. It is preferable to repair the existing historic materials/replace in kind, rather than replace. If repair is not possible, an alternate replacement product such as engineered composite polymer tiles closely resemble the look and feel of glazed and natural terra cotta tile.

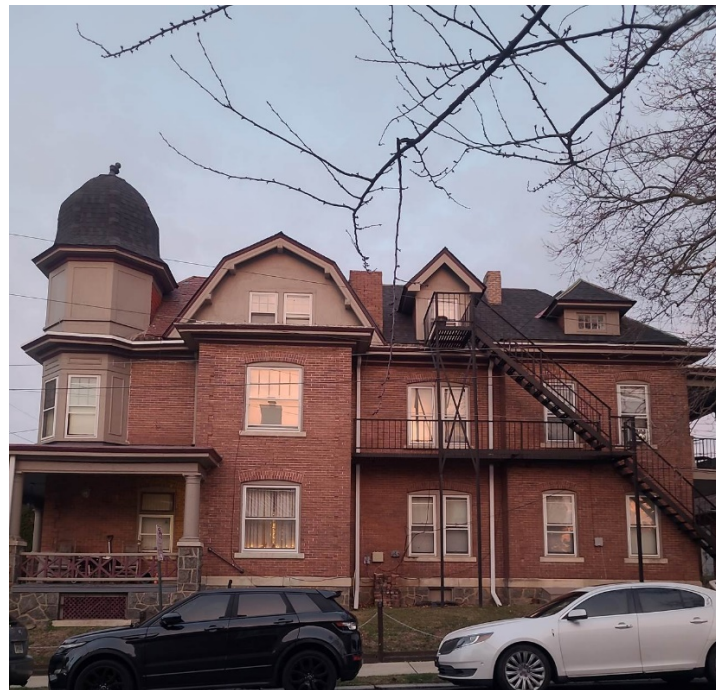
The proposed work is to remove the existing clay tile roof at the main roof area and replace with a substitute product. The applicant notes that the turret dome and rear roof were replaced by a previous owner, and that replacement roof is black asphalt shingle.

Side Elevation (Applicant)

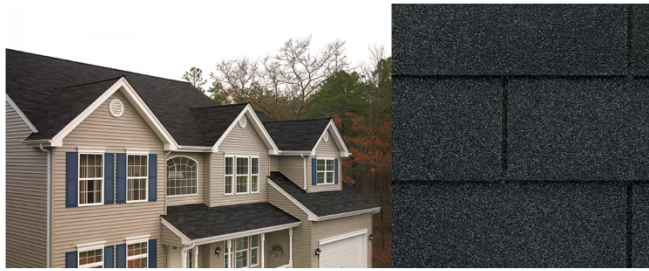
Option 1: Charcoal 3-Tab (Applicant)

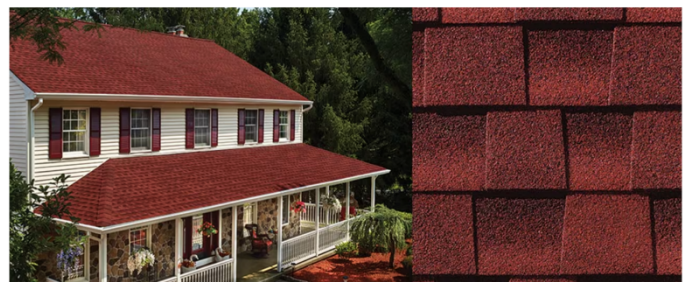
Option 2: Patriot Red Timberline HDZ architectural shingle (Applicant)

Mr. Jordan and Mr. Jones clarified that this application is not a violation correction; it is an application for the repair. Given the lack of appropriate replacement material options, Mr. Jordan noted that the application may not be able to move forward. The architectural shake submitted is not approvable due to its difference in shape.

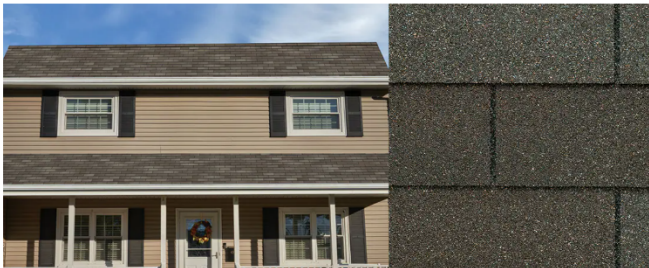
Option 3: Royal Sovereign Weathered Grey 3-Tab (Applicant)
