Allentown Historical Architectural Review Board
FINAL Review Sheet

HDC-2024-00023

Address: 534 N. 6th Street

Proposal: Replace windows, exterior wall material, and roofing related to fire damage

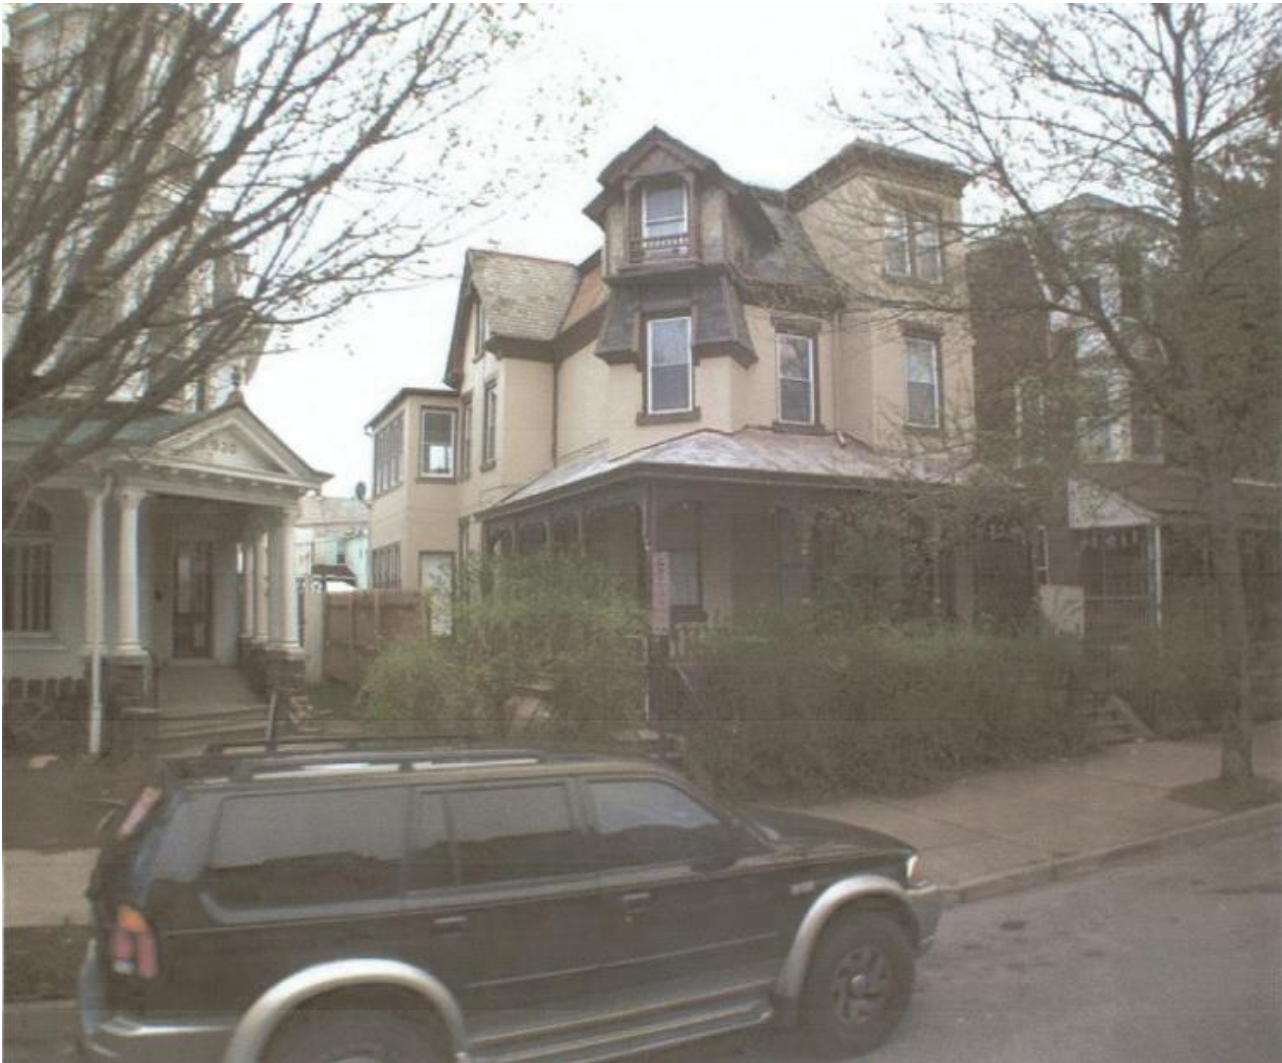
Previous Photograph Prior to Fire Damage (Applicant)

The proposed replacement roofing is a beveled asphalt shingle, but it is not clear from the provided images if this matches any existing slate roofing or is present on similar/adjacent buildings. Clarification may be required for this item. From the photographs and Google Street View, all that can be discerned is 3-tab shingles at the front roof and metal on the porch roof.

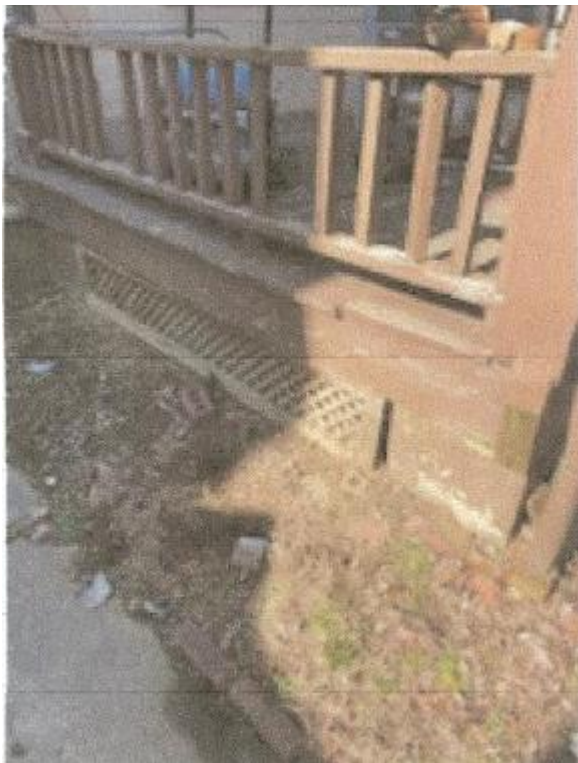
Front Deck (Applicant)

The proposed work at the front porch and railings is also consistent with the design guidelines.

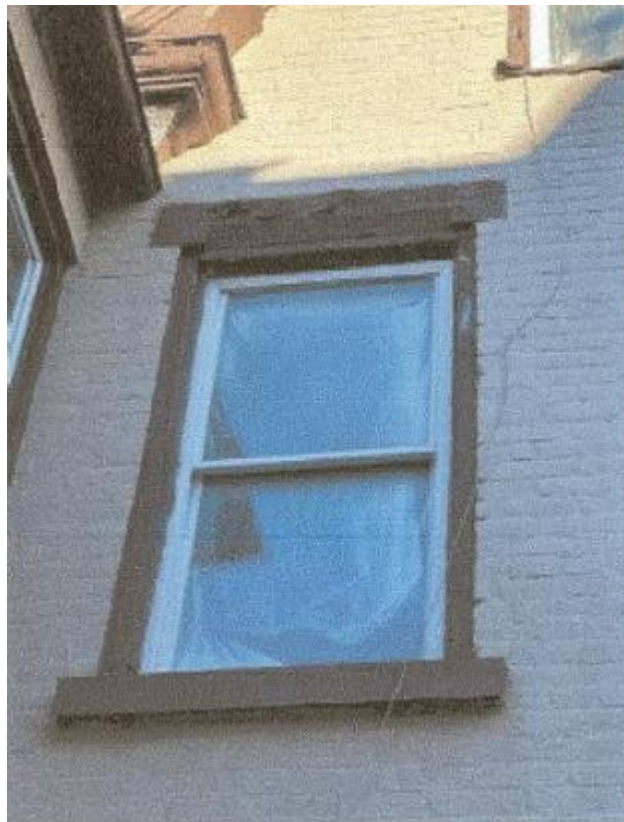
Typical Window (Applicant)

Observations & Comments: The window replacement with aluminum clad wood windows is historically appropriate if they match the existing 1 over 1 double hung configuration.

- Replacement aluminum clad wood windows will match the existing 1/1 configuration.
- Replacement shingles will match the existing slate in style, color, and shape.
- Replacement downspouts will be replaced in-kind.
- Mortar will match the original in composition, strength, hardness, color, and texture and is tooled with the same profile as the original.

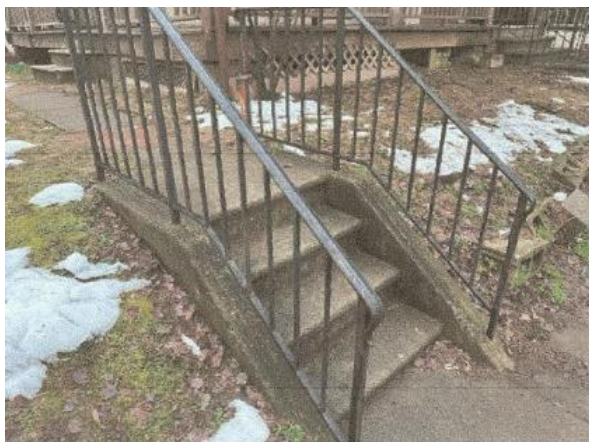
Front Stair Railing (Applicant)

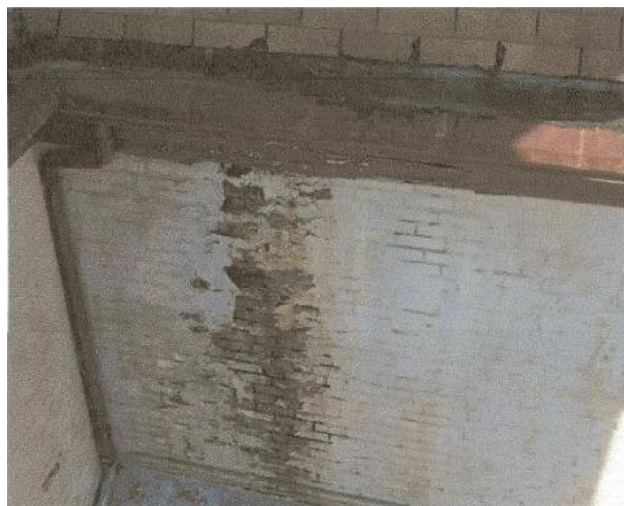
Damaged Wall Paint (Applicant)

Work related to repointing the brick is appropriate – as long as the mortar used is compatible and matches the original in composition, strength, hardness, color, and texture and is tooled with the same profile as the original. Since the brick is already painted, touching up of the paint at the masonry is also appropriate.
