**Historical Architectural Review Board  
COA Final Review Sheet**

**HDC-2023-00074**

**Address: 1539-51 W. Chew Street**

**Proposal: Convert church to mixed use and rehabilitate envelope**

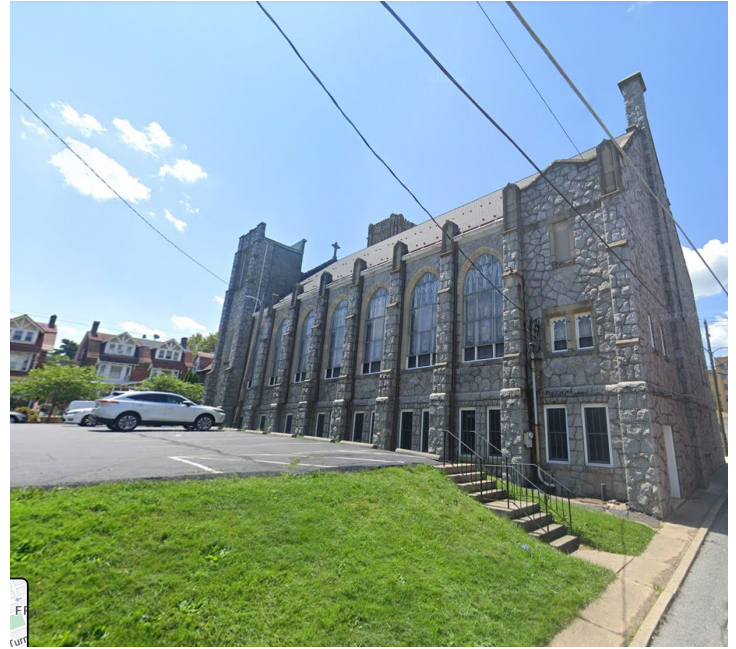
**View of the church and parking lot from Monroe Street, 2023.  
(Google StreetView)**

The application proposes to locate a dumpster with a retaining wall along Monroe Street adjacent to the parking area. The gate and material for the retaining wall have been provided. The application proposes to install a PVC plank gate in a woodgrain texture finish. The retaining wall would be comprised of a split-face block in a gray-beige color to complement the masonry of the historic structure. Staff finds that because the dumpster area is located at the rear of the side yard, the design and materials would not have an adverse impact on the church building, are appropriate, and comply with Guideline 3.12.12.

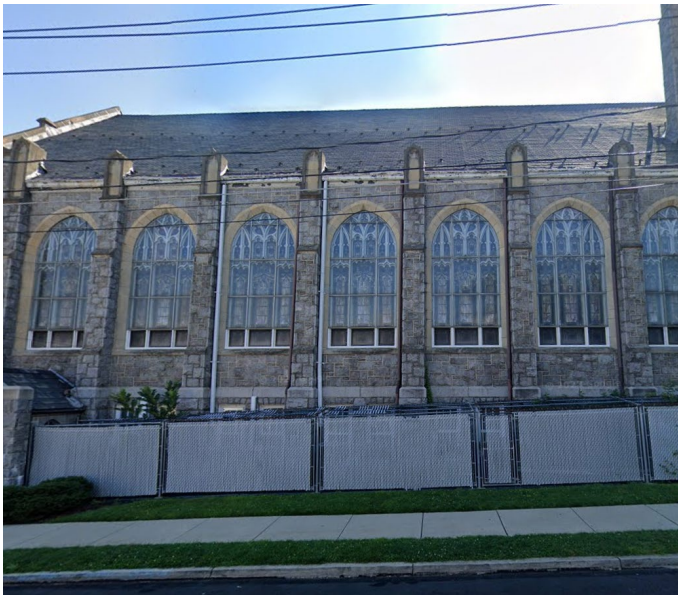
**Windows on the west elevation to be replaced, 2023.  
(Google StreetView)**

The applicant has updated the windows proposed to replace the stained-glass windows, which are identified in note W7 in the drawings. The change includes an adjustment to the operable window and mullion placement within the window system resulting from energy code requirements. Staff finds the change to be relatively minor and has no objection.

The applicant also provided two options for the double-hung sash windows at the building's lower level. The historic windows include a three-over-three configuration, and the applicant proposes to maintain the placement of the muntins to replicate the historic appearance. The difference in the options is material, with a proposal for an aluminum-clad wood window and a fiberglass window. Staff notes that Guideline 3.5.9 gives preference to the aluminum-clad wood window though fiberglass is also acceptable. Staff supports the use of either option.

- The stained-glass windows proposed for replacement should be documented prior to removal and salvaged to the greatest extent possible;
  - The existing conditions of the 16<sup>th</sup> Street entrance should be thoroughly documented prior to any work commencing to comply with Guideline 3.14.7;
  - Floodlights should be mounted inconspicuously and appropriately;
  - All new light fixtures should be attached in a manner that does not damage historic materials or obscure architectural features;
  - All new light fixtures should be anchored into mortar joints rather than stone; and
  - All conduit should be concealed at primary facades.
-

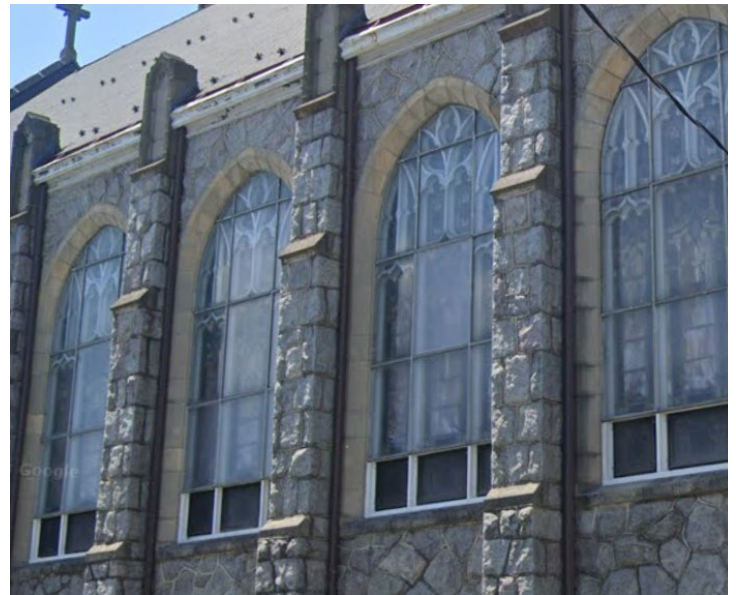
**Windows on the east elevation to be replaced, 2023.  
(Google StreetView)**
